Geotechnical Assessment

## White Rock Quarry

# Geotechnical Review and Response to DEM

Prepared for: Hanson Construction Materials

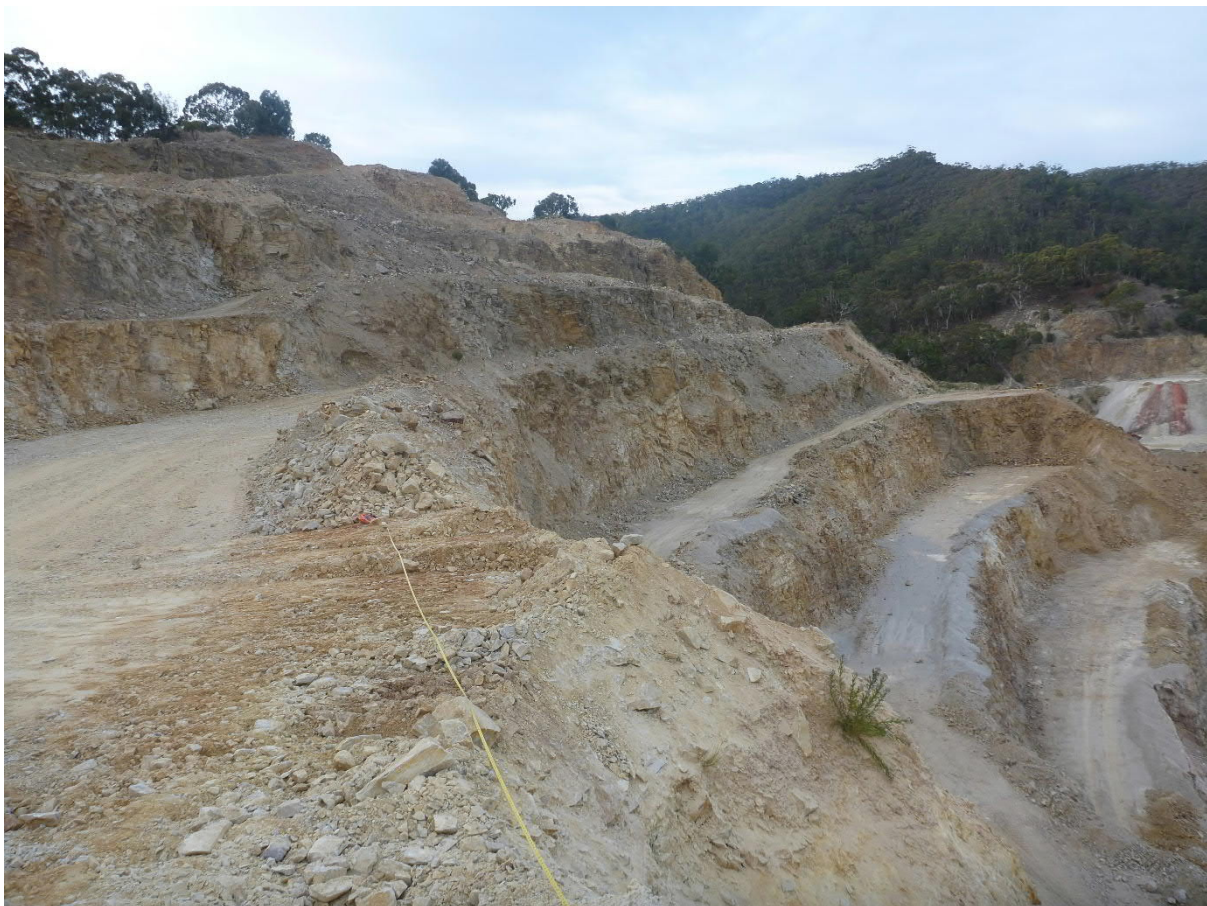
Plate 7: The eastern highwall in section is a bedded moderate strength metamorphosed rock mass which while jointed perform well in service as is clearly evident in this image. Bedding is sub horizontal and the rock mass is not folded to any significant degree. Minor warping of the bedding planes and small scale fault displacements are also recognised in this wall.

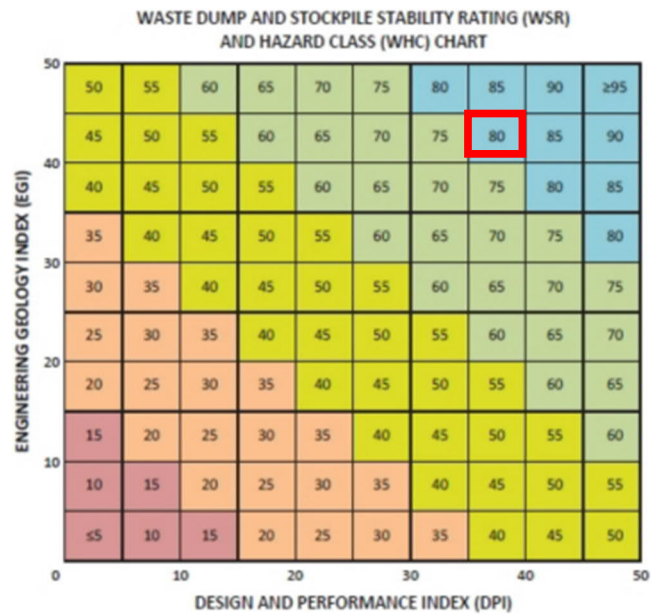
Figure 3.4 WHSRC Assessment Chart

Figure 3.4: Waste dump and stockpile stability rating and hazard class chart

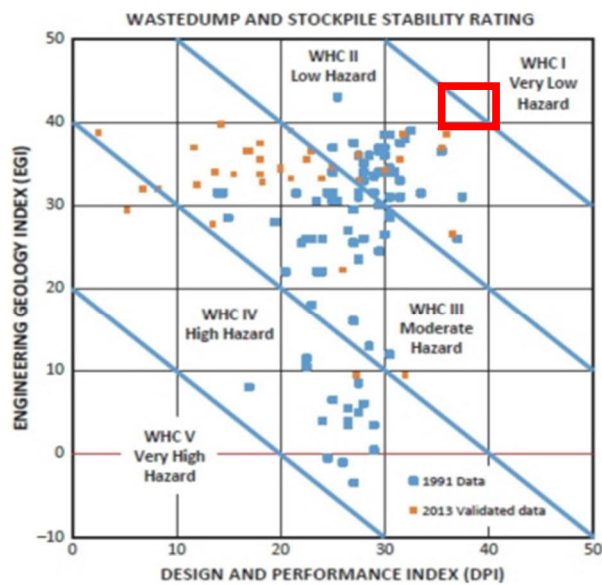
Figure 3.5 WHSRC Assessment Chart Historical Data

Figure 3.5: Waste dump and stockpile stability and hazard chart illustrating the results of the 1991 and 2013 surveys

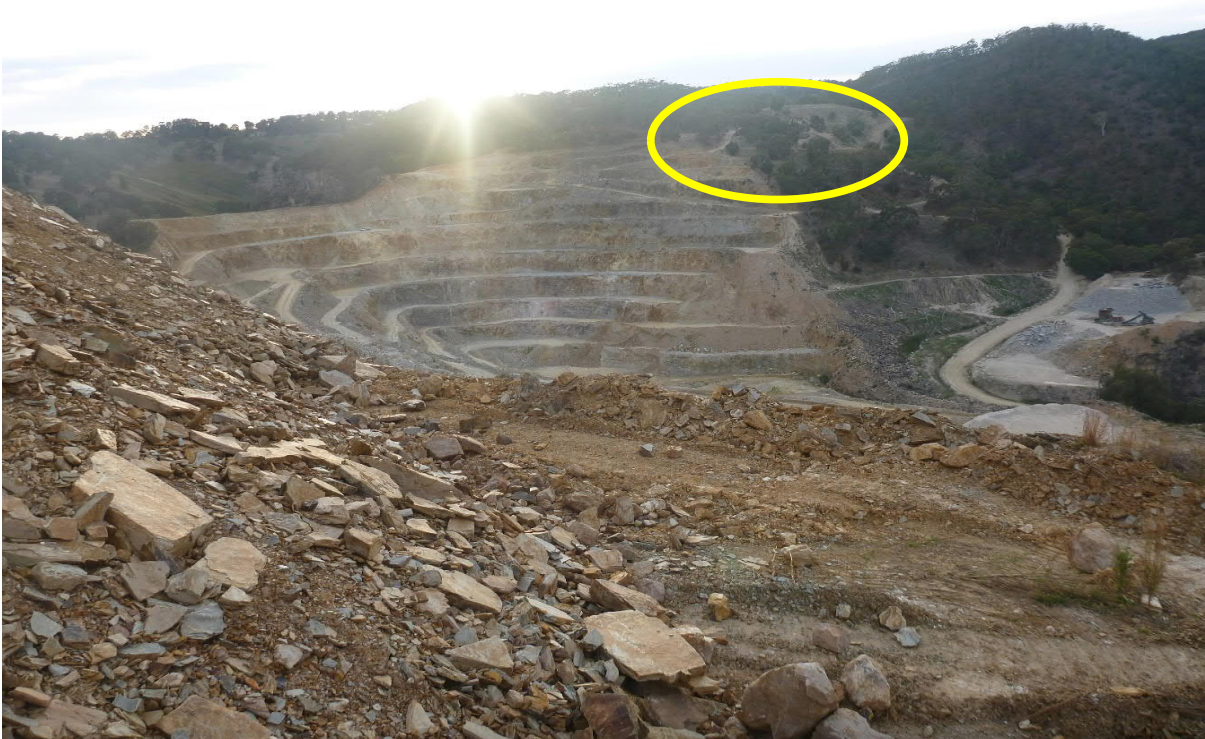
Plate 8: The White Rock Quarry is already a significant operation which has a current total slope height of 120 metres in the east wall which will not materially change resultant of this proposal in the final bench heights. That is the slope heights which currently exist will not significantly change and the driving and gravitational forces which are currently managed by the slope design are expected to be similarly managed by the future design which largely uses the same design criteria. The overburden (yellow circle) is also partly visible in this image, which is treated as an extension of the quarry, although several areas of overburden exist.

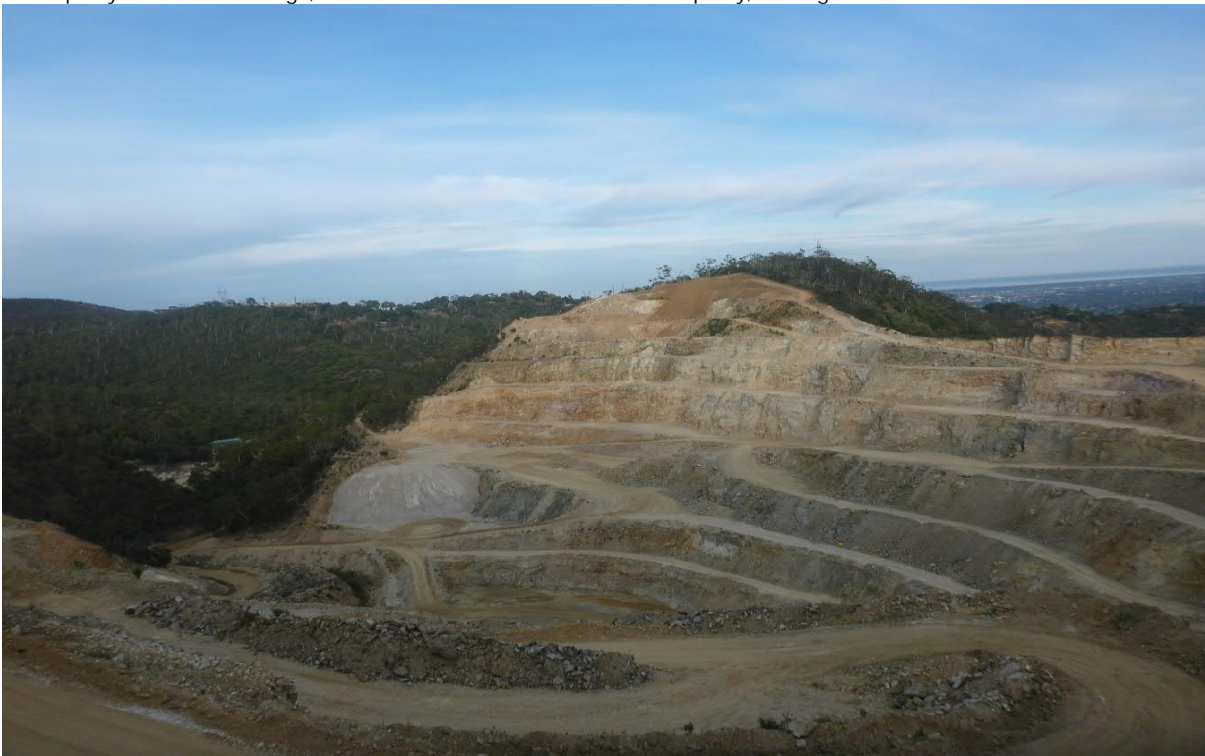
Plate 9: The west wall of White Rock Quarry is similarly already a very significant slope which shows no material signs or vectors denoting slope instability.

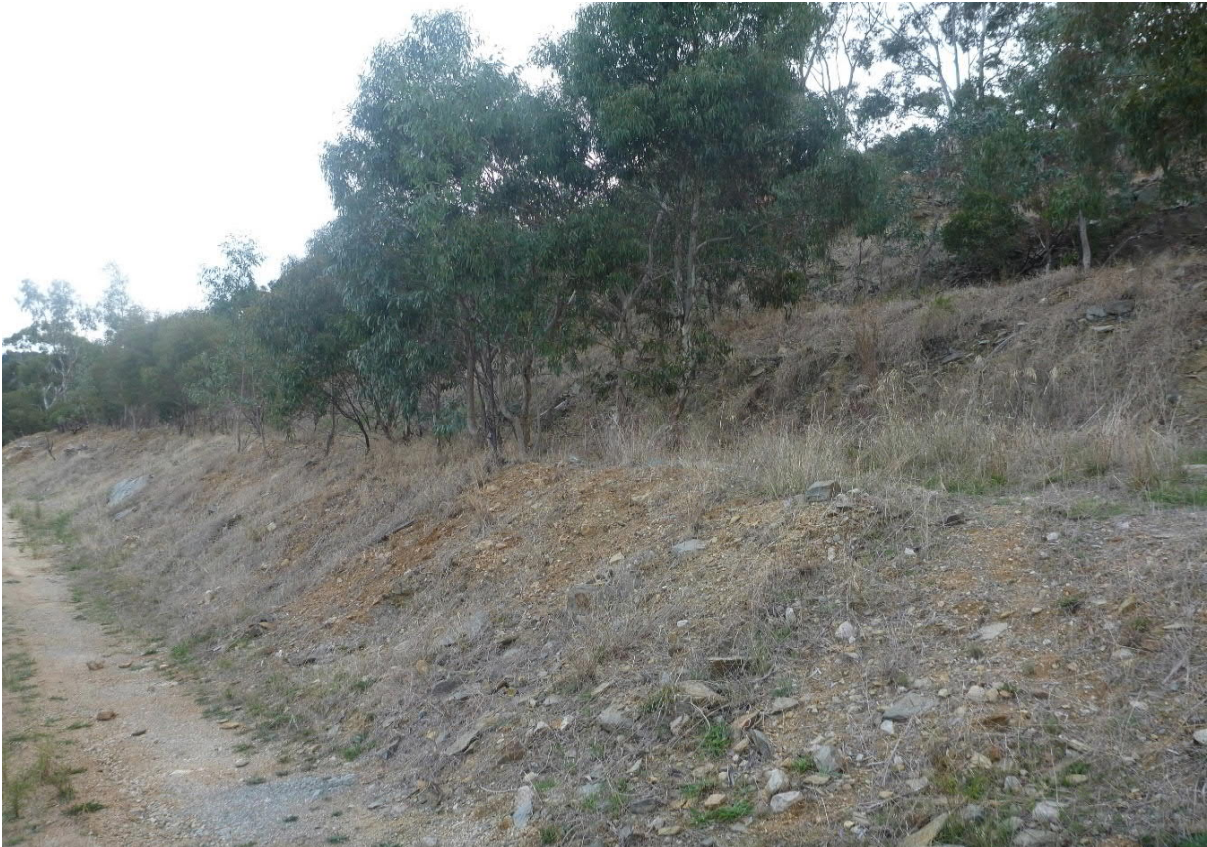
Plate 10: A portion of the east wall waste dumps which are proposed to be reclaimed as part of the project. Clearly for this part of the overburden area it will be a very straight forward earth moving exercise.

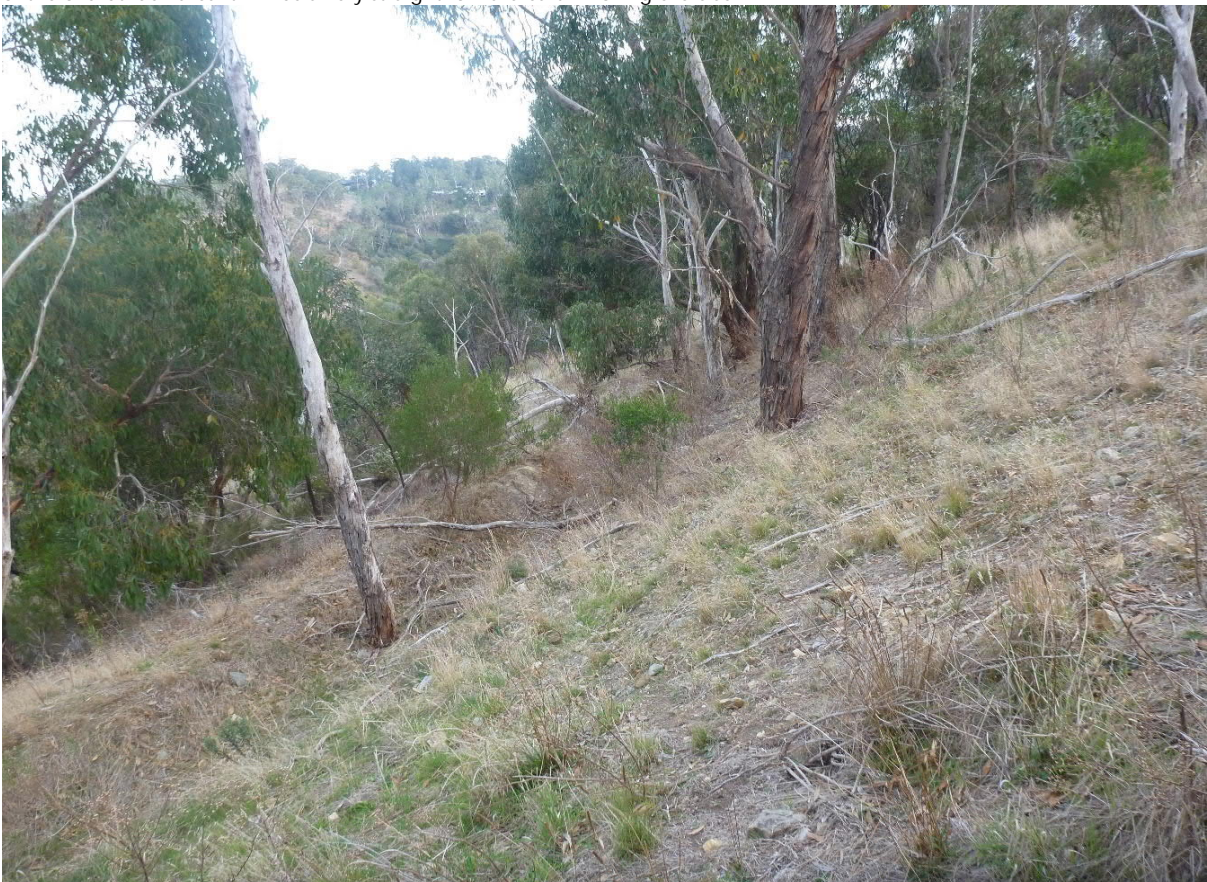
Plate 11: A further view of the White Rock overburden areas which are not steep or of any perceived difficult regarding reclamation activities.

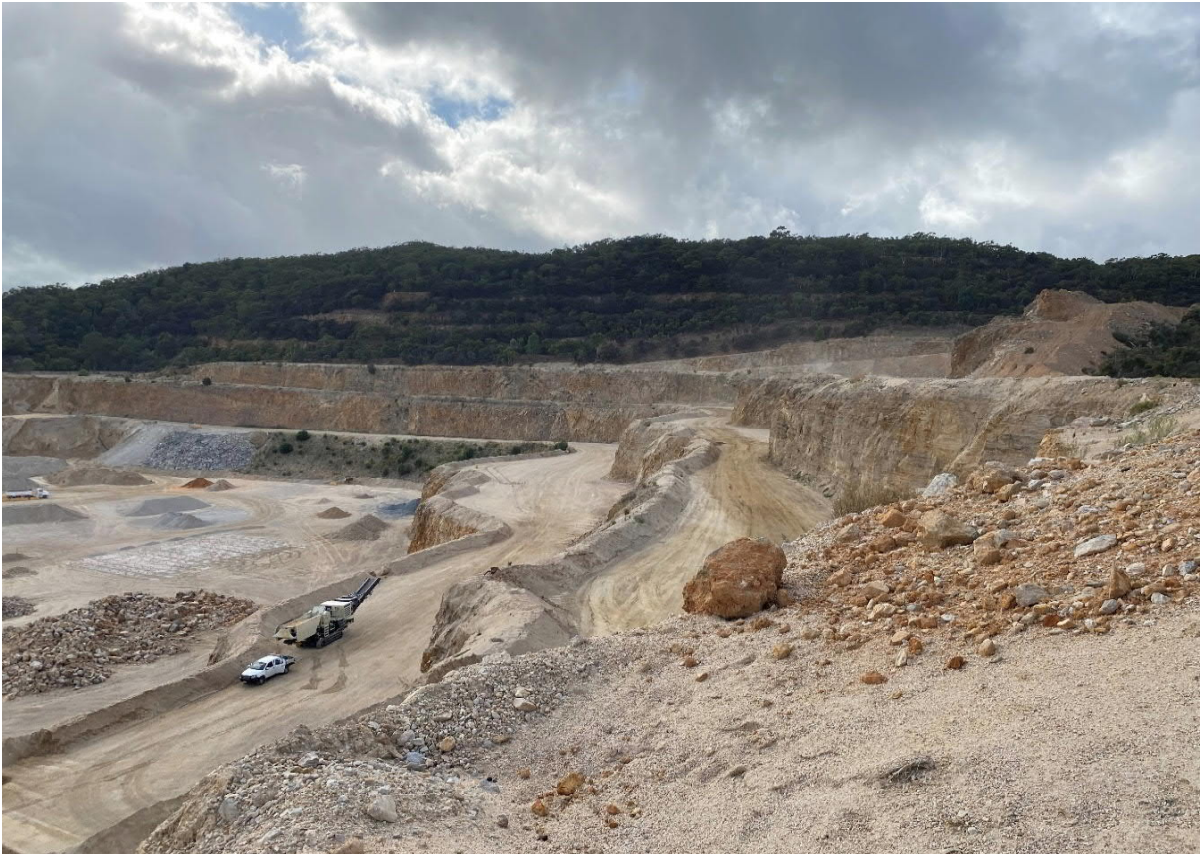
Plate 12: A view of the ongoing rehabilitation at nearby quarry , provided courtesy of Quarry Magazine August 2012. This rehabilitation strategy would be similar to what is proposed for the western portion of the quarry.

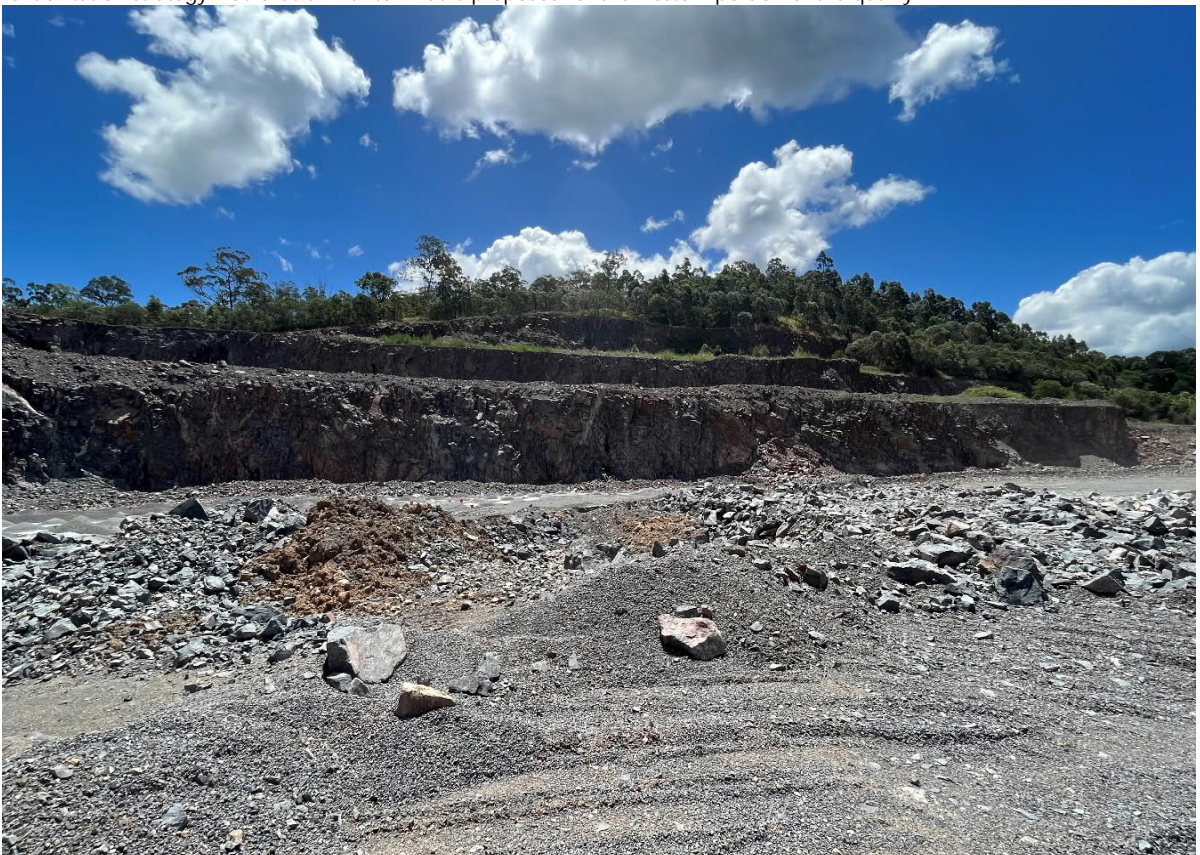
Plate 13: A view of the ongoing rehabilitation at another quarry with rehabilitation completed in the right and moving slowly to the left of page.

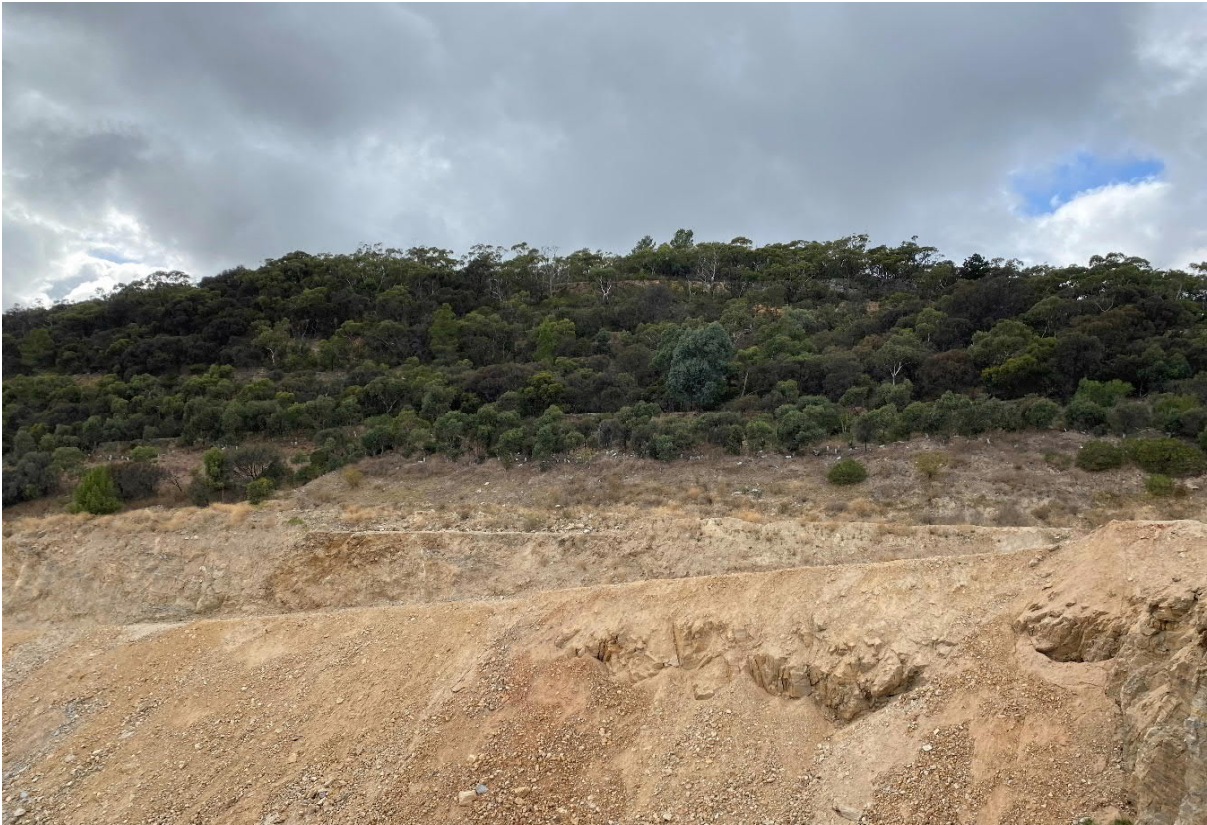
Plate 14: A closer view of the ongoing rehabilitation at another quarry using a bench profile as rehabilitation, provided Courtesy of Quarry Magazine August 2012.

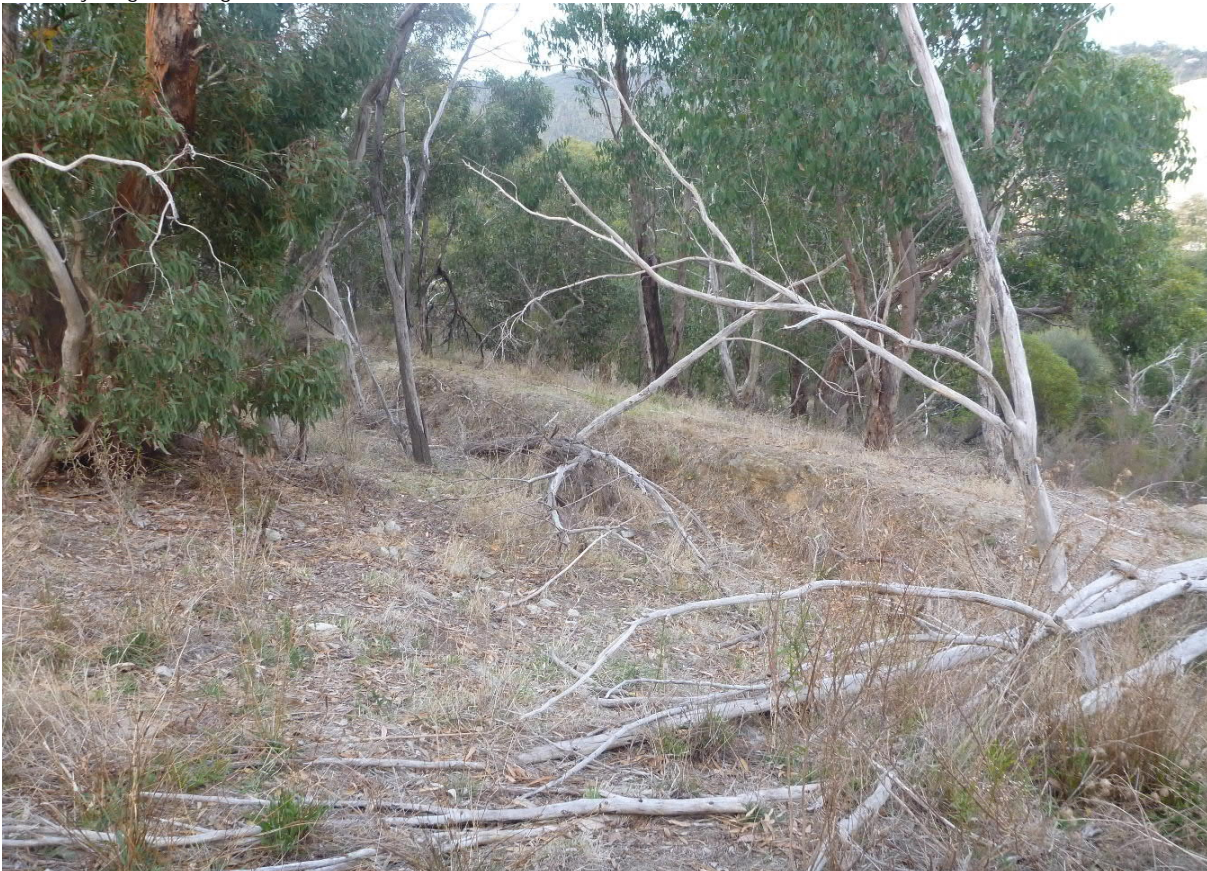
Plate 15: A closer view from the top of the overburden stockpile areas at White Rock, showing the very gentle nature of the material to be reclaimed.

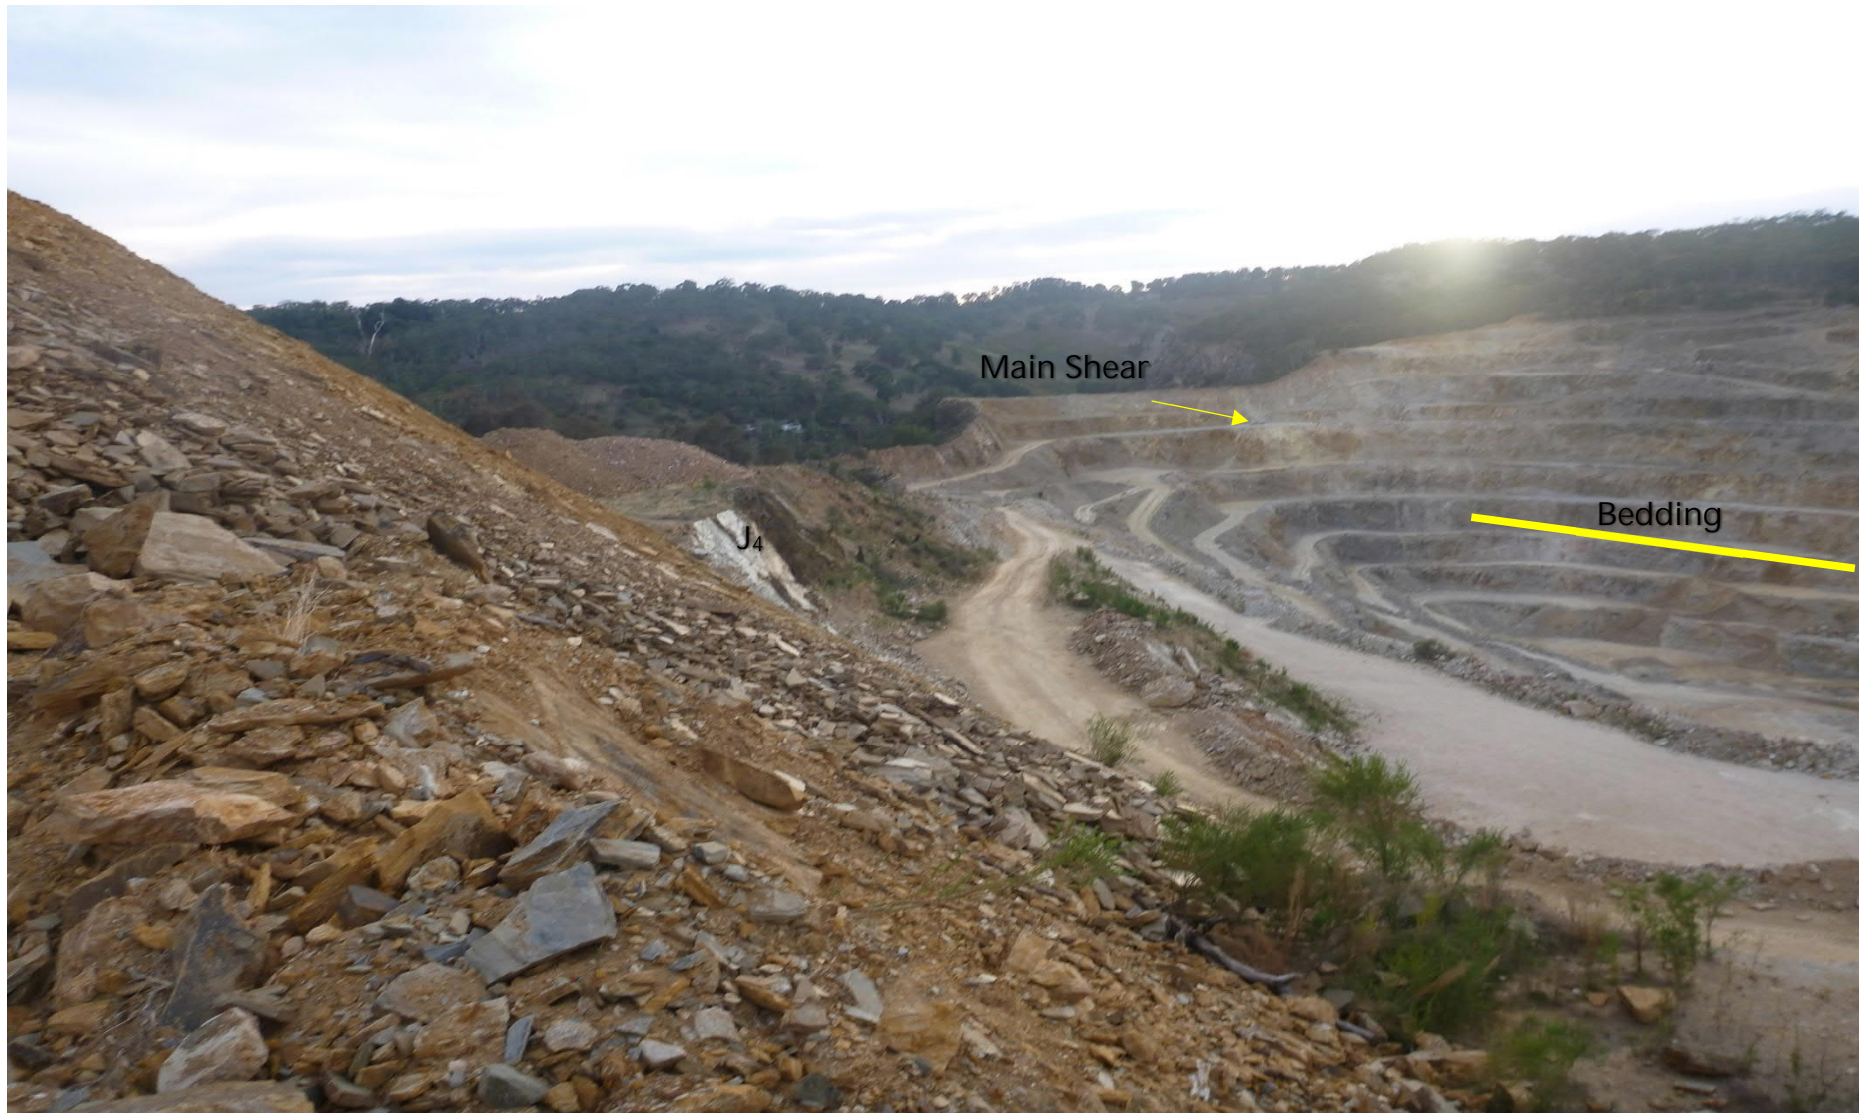
Plate 16: This image shows a few of the main structures on site which have been considered as part of the geotechnical assessment.

To complete the kinematic analysis structural data was recorded and then assessed in Rocscience Dips for Planar, Wedge and Topple potential. Resultant of the kinematic assessment it is clear that minor topple, wedge and planar potential will remain in the majority of bench areas. Importantly shallowing the benches increases planar risk but reduces wedge potential so when balancing all the competing issues of batter design a 70-80 degree batter angle is considered a realistic and pragmatic outcome. Based on the kinematic assessment the following potential failure methods are provided for each wall, refer Plates 19 to 30 while the main structures are illustrated on Plates 16 to 18.

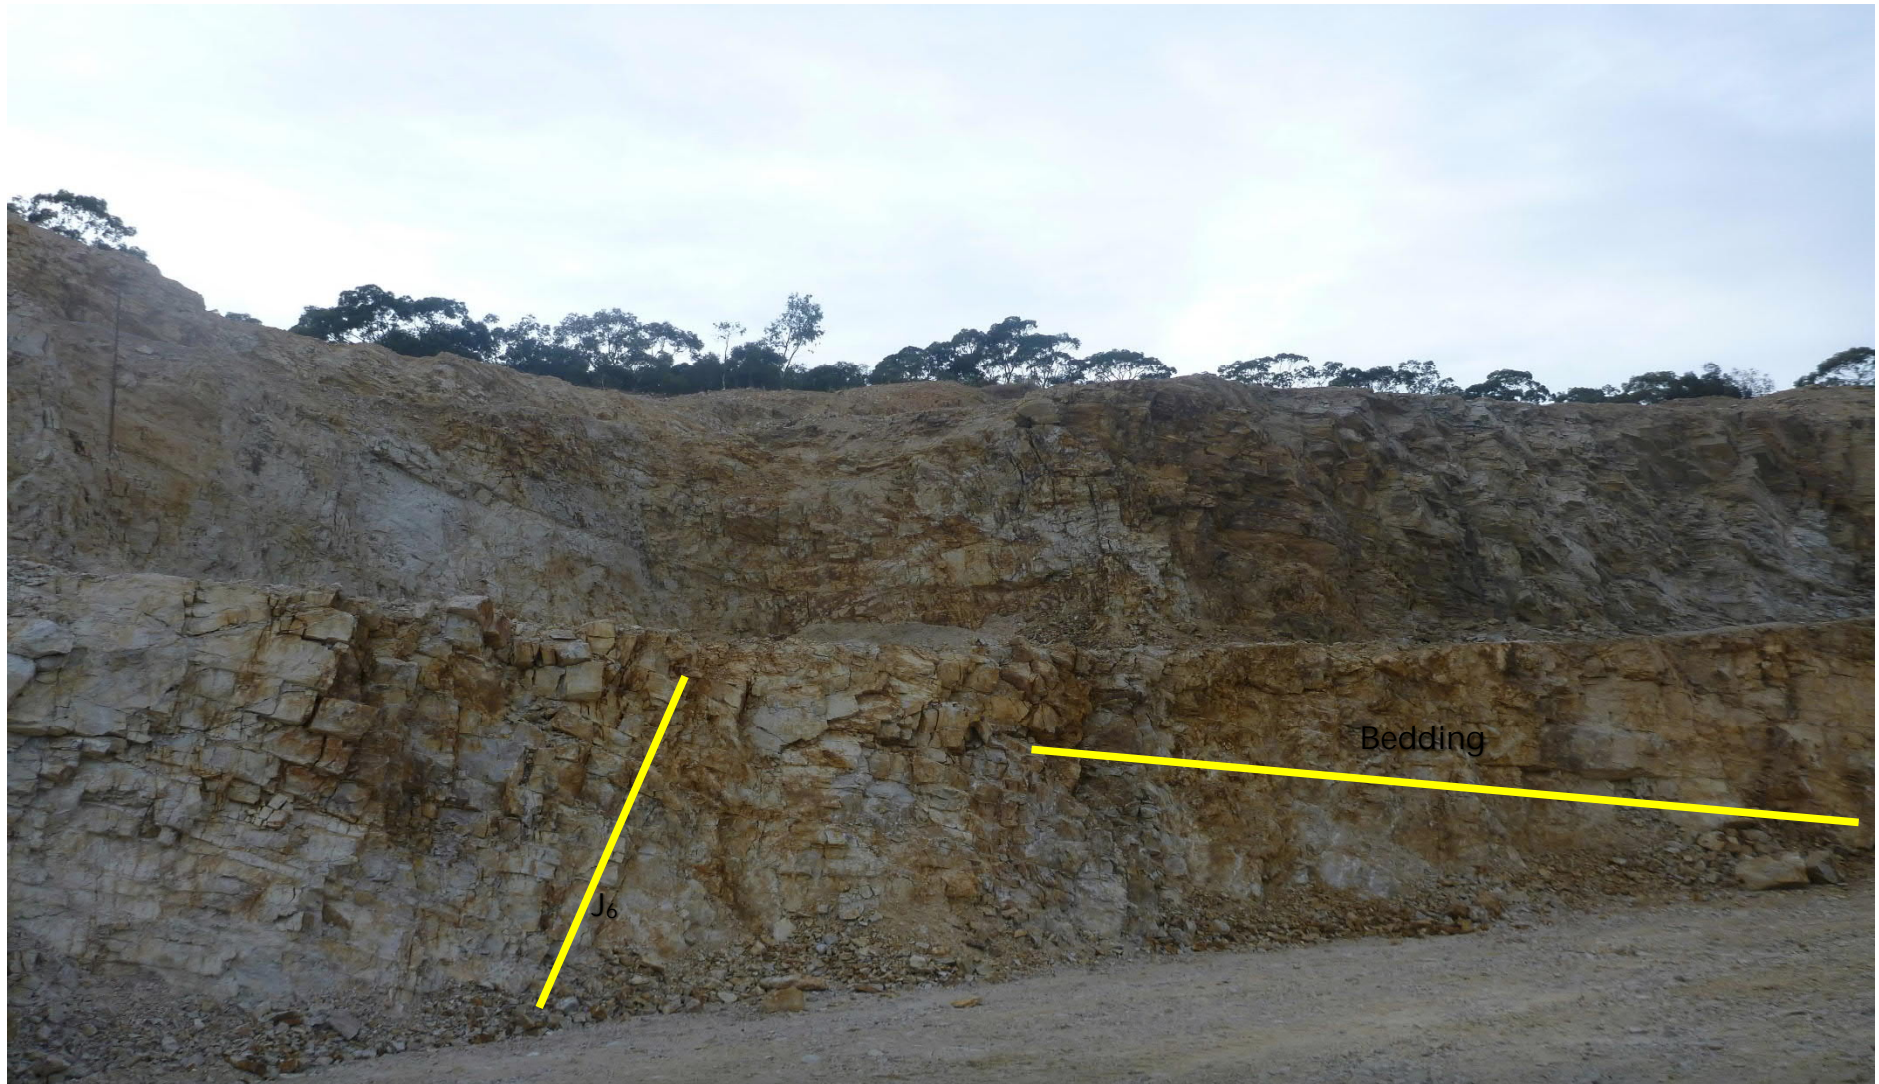
Plate 17: A further image which shows the comparatively small block size the intensity of the jointing and the degree of weathering encountered on site in the upper benches.

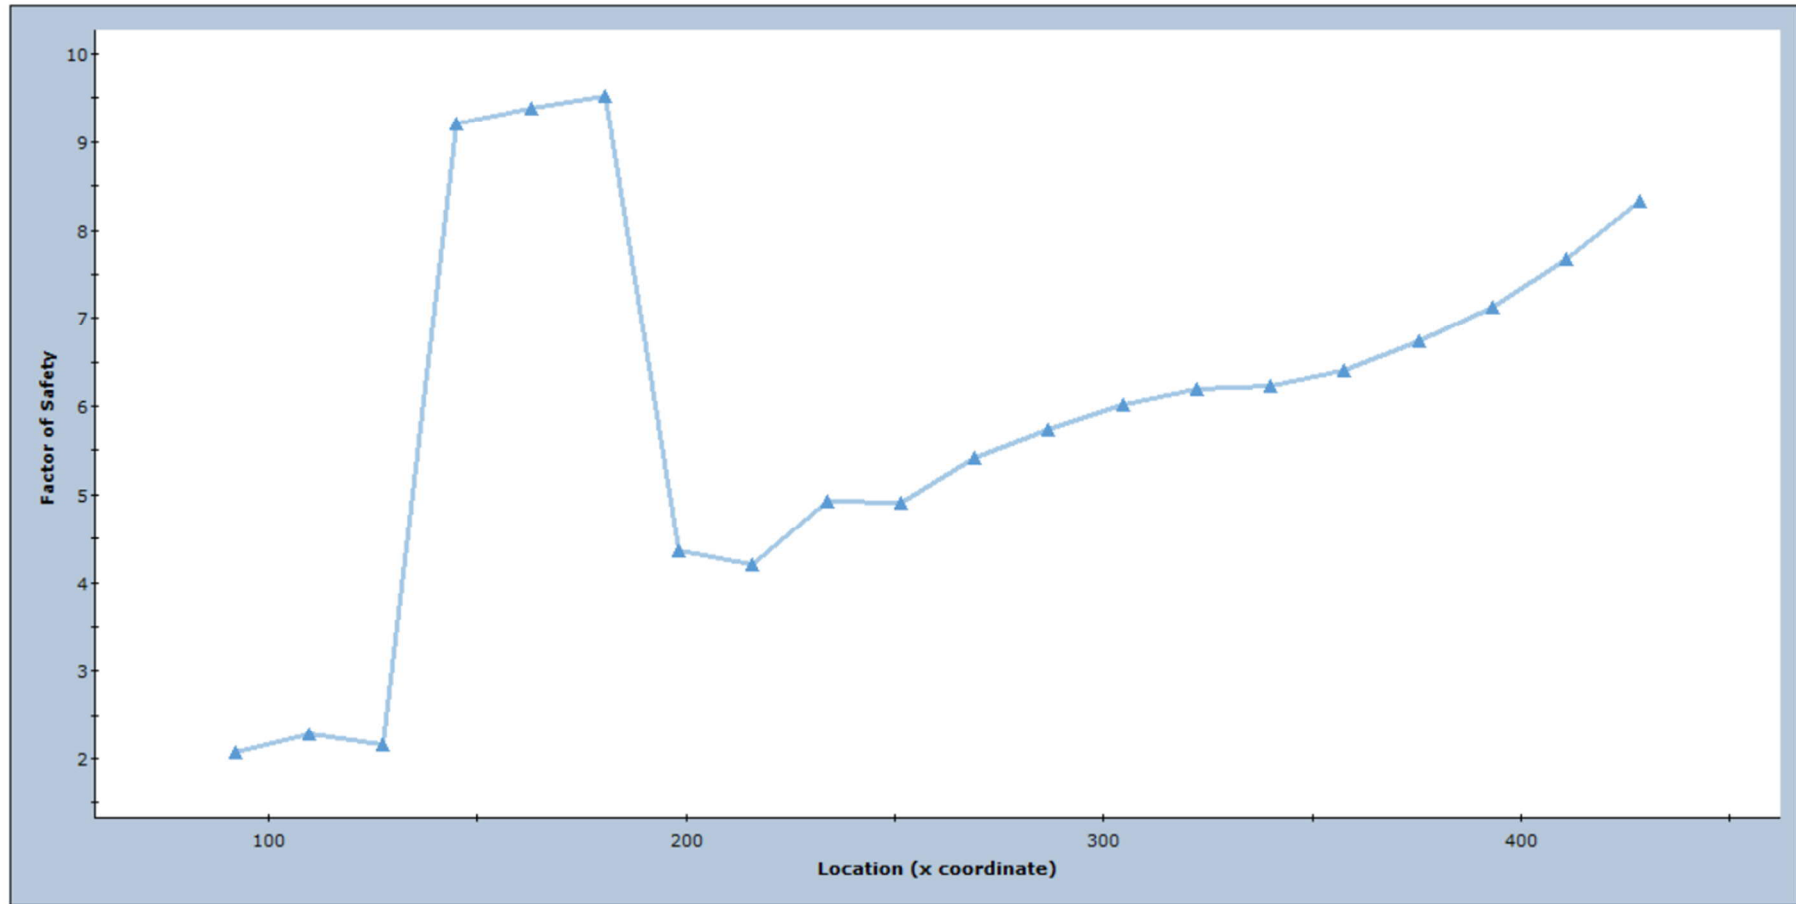
Plate 34: A graph of FOS along Section B, north wall with the minimum FOS encountered at the base of the distinctly weathered material. Critically several small failures have developed like this, so this model calibrates well with site conditions. The lower FoS in this instance are associated with the lower strength materials weathered encountered at the tope of the ridgeline.

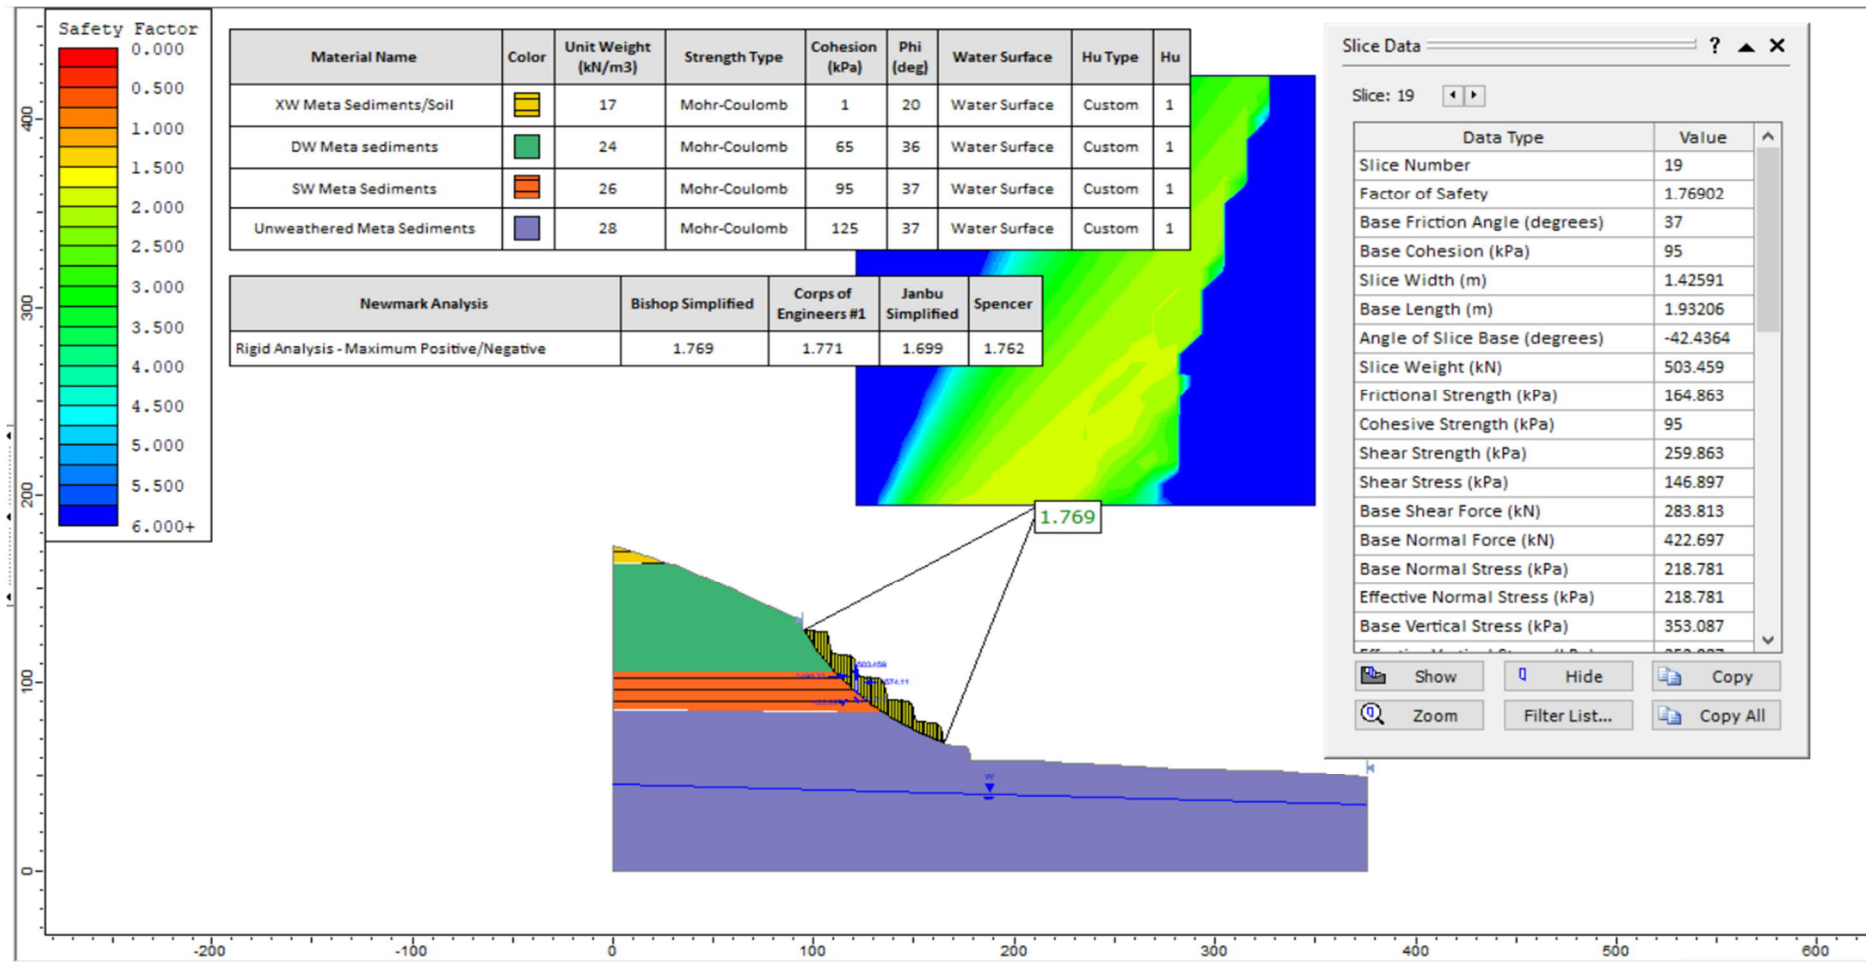
Plate 39: Section E south wall limit equilibrium assessment was completed to assess slope stability issues and FoS levels. FoS levels approximate 1.7 which is stable with the minimum slip circle shown. This slope has a similar failure mechanism to the section C in that it demonstrates that slope heights are starting to impact slope performance as is the weight of the slope above the cutting . This is why this slope has been buttressed along with the eastern part of the north wall to improve the long term FoS. When buttressed this slope increases the FoS to > 2. A FoS of 1.5 is suitable for operational slopes.

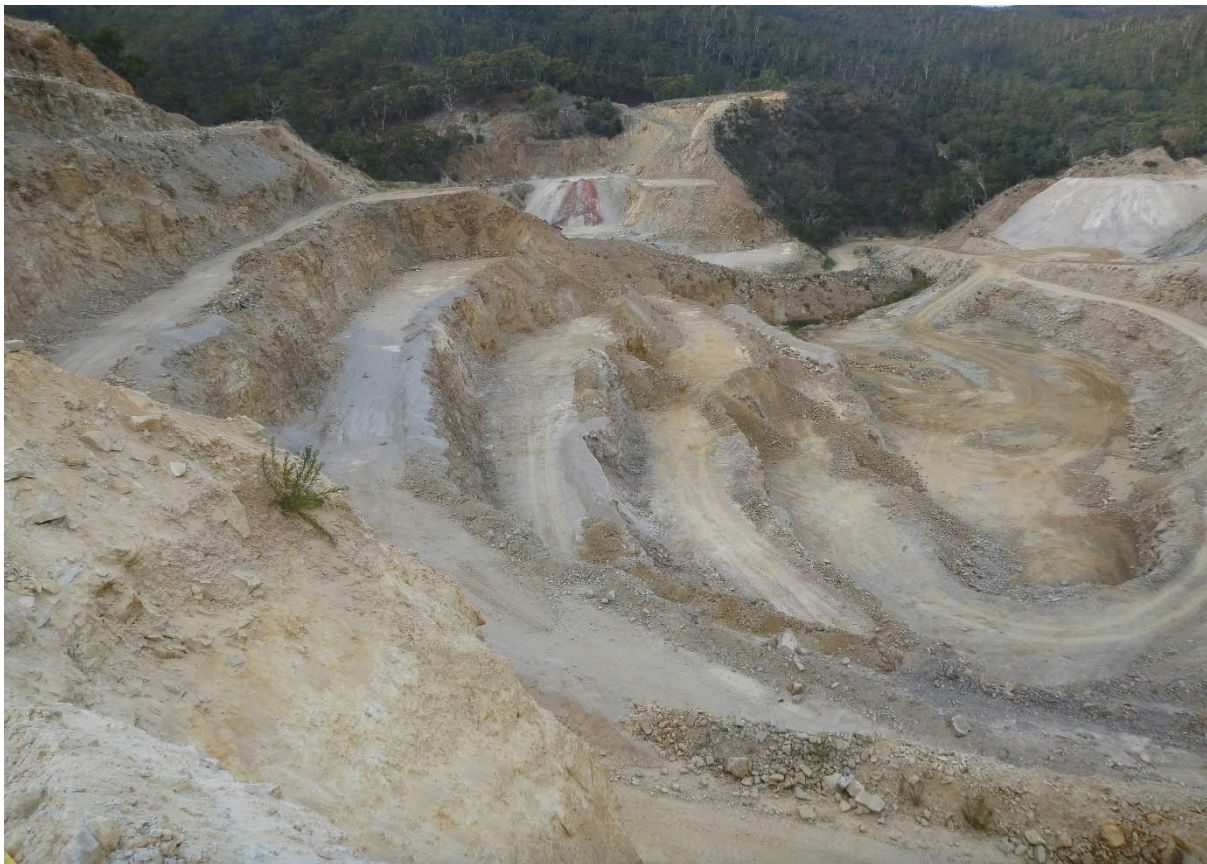
Plate 46B: Looking toward the southern extraction area in this distance which has already been partially extracted.

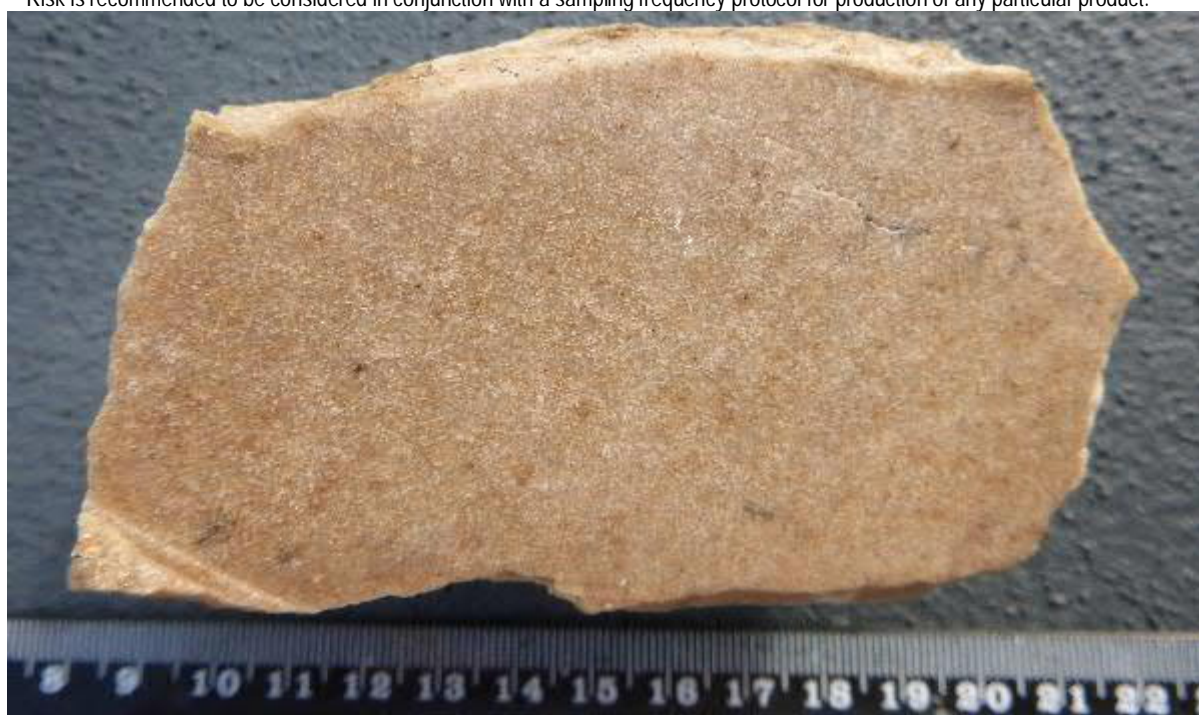
Plate 1: Photograph displaying sectioned face of the quartzite including fine to medium grain size of constituent quartz and feldspar.

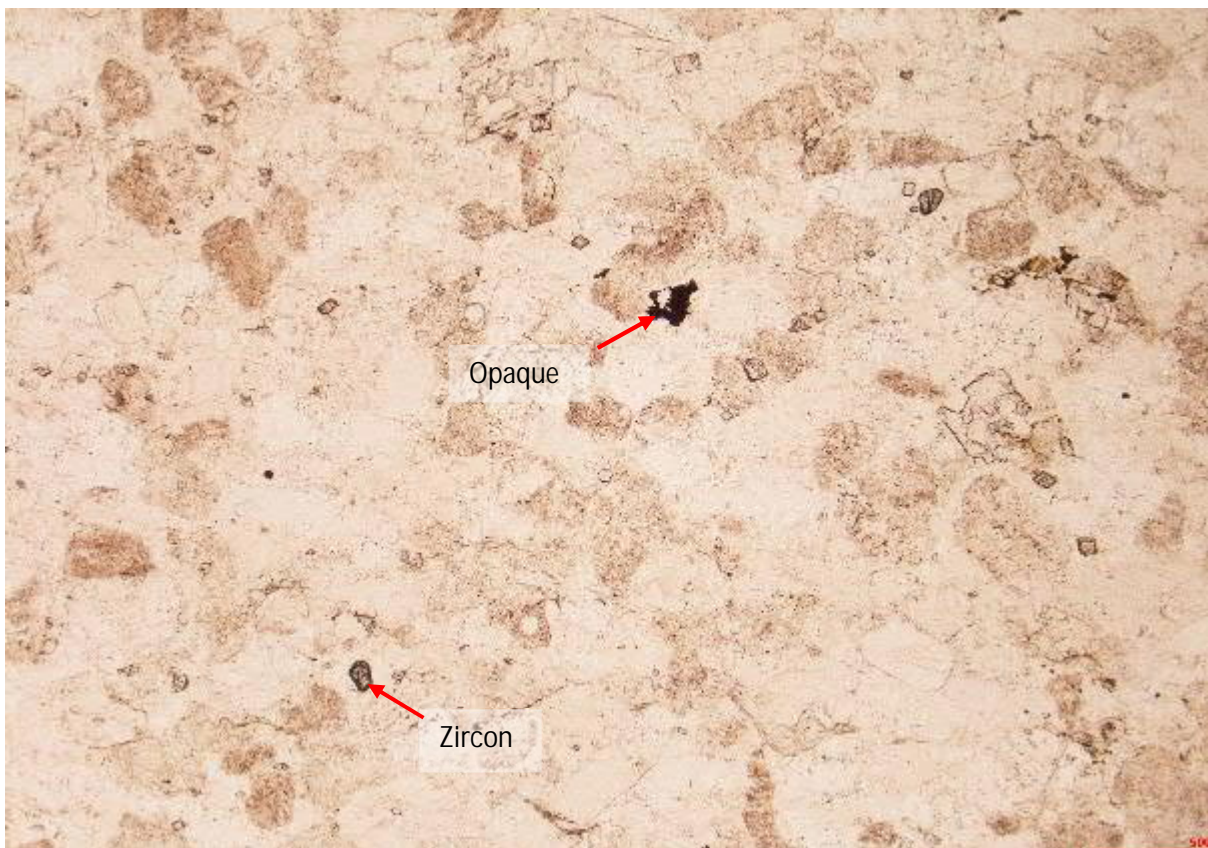
Plate 3: Microphotograph utilising plane polarised light to better distinguish dusty feldspar profiles from clear quartz and illustrate calcite, opaque and rare zircon distributions within the quartzite.

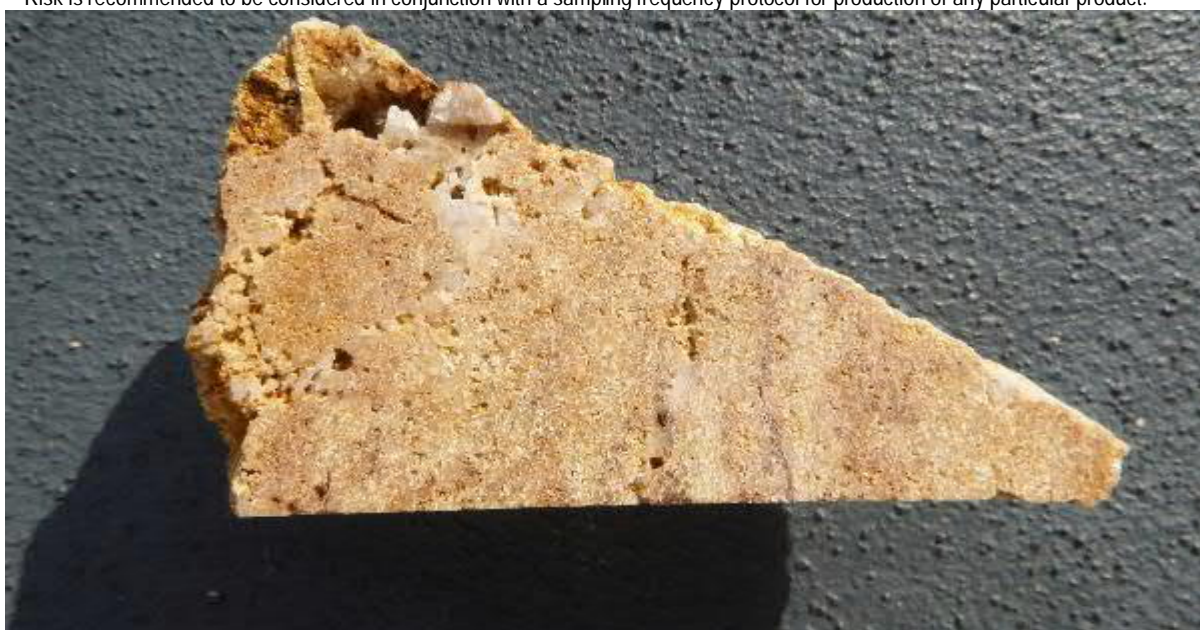
Plate 1: Photograph displaying sectioned face of the quartzite including medium and coarse grain size of constituent quartz and feldspar as well as a pervasive network of ferruginous veins and associated weathered voids.
