Geotechnical Assessment

## White Rock Quarry

# Geotechnical Review and Response to DEM

Prepared for: Hanson Construction Materials

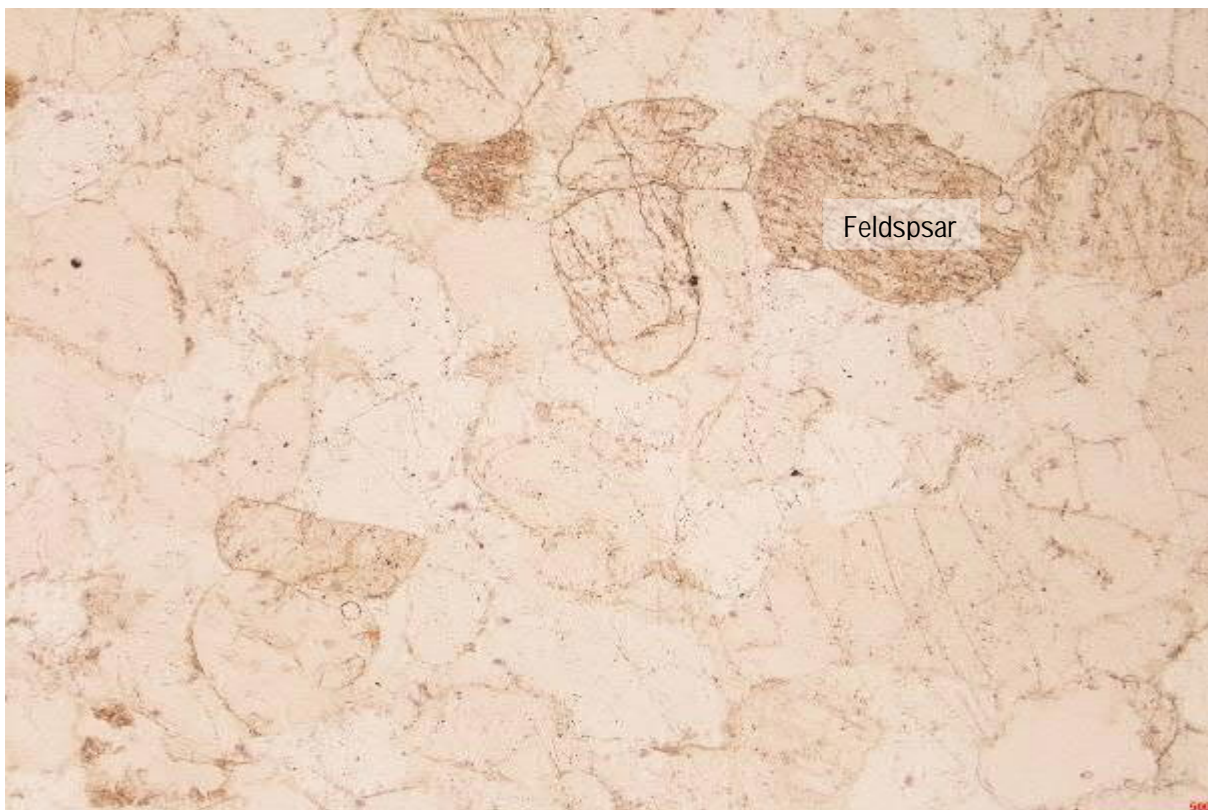
Plate 3: Microphotograph utilising plane polarised light to better distinguish dusty feldspar profiles from clear quartz and illustrate calcite, opaque and rare zircon distributions within the quartzite.

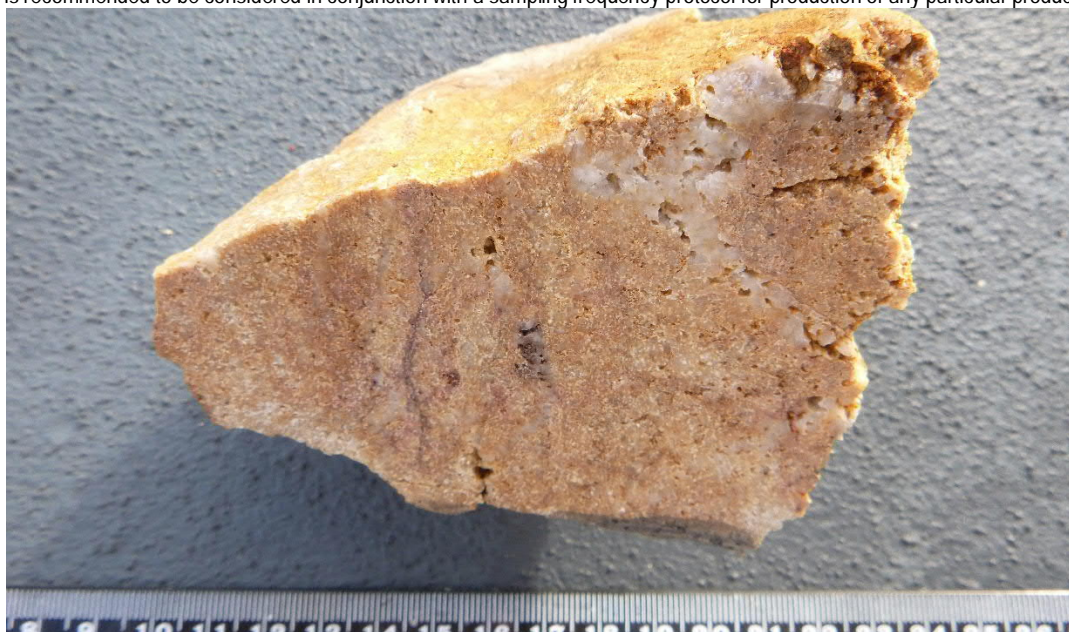
Plate 1: Photograph displaying sectioned and fractured face of the quartzite both of which exhibit the ferruginous and voided vein network characterises much of the rock. Constituent grains are generally coarse and recrystallised quartz account for much of the sample's veins.

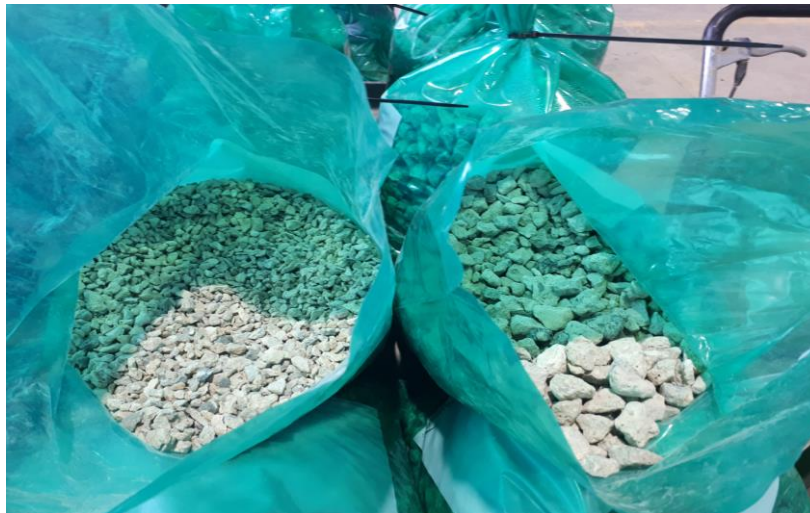
**Image 2.** Recycle aggregate from White Rock Quarry

White Rock Quarry has successfully undertaken crushing campaigns of recycled materials utilising the current mobile crushing plant located within the pit. In future concrete returns will be reprocessed in the same manner during broader aggregate crushing campaigns.
