White Rock Quarry Treatment Product Assessment

DATE: 31/05/2022 REFERENCE: 3097TURB

SUBJECT: White Rock Quarry Treatment Product Assessment

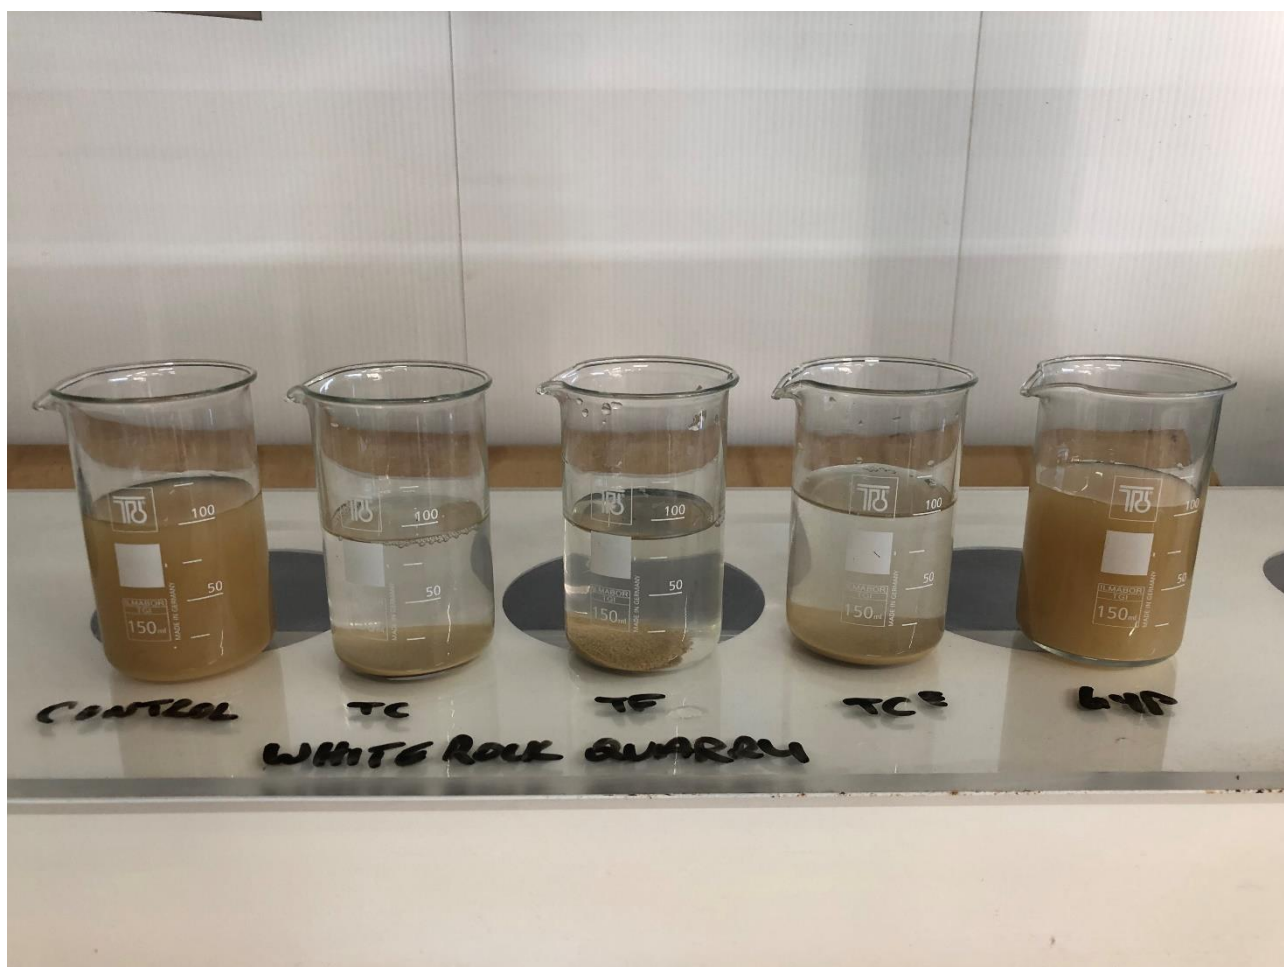
Image 1. Jar Testing results

The water sample was analysed for starting pH and turbidity and subsequently subjected to various dose rates of Turbiclear, Turbifloc, Turbiclear Extra and Turbi Gyp to facilitate flocculation of the suspended solids within 1L samples. Settlement was observed over a depth of 100mm over various timeframes from 5 minutes to 1 hour.

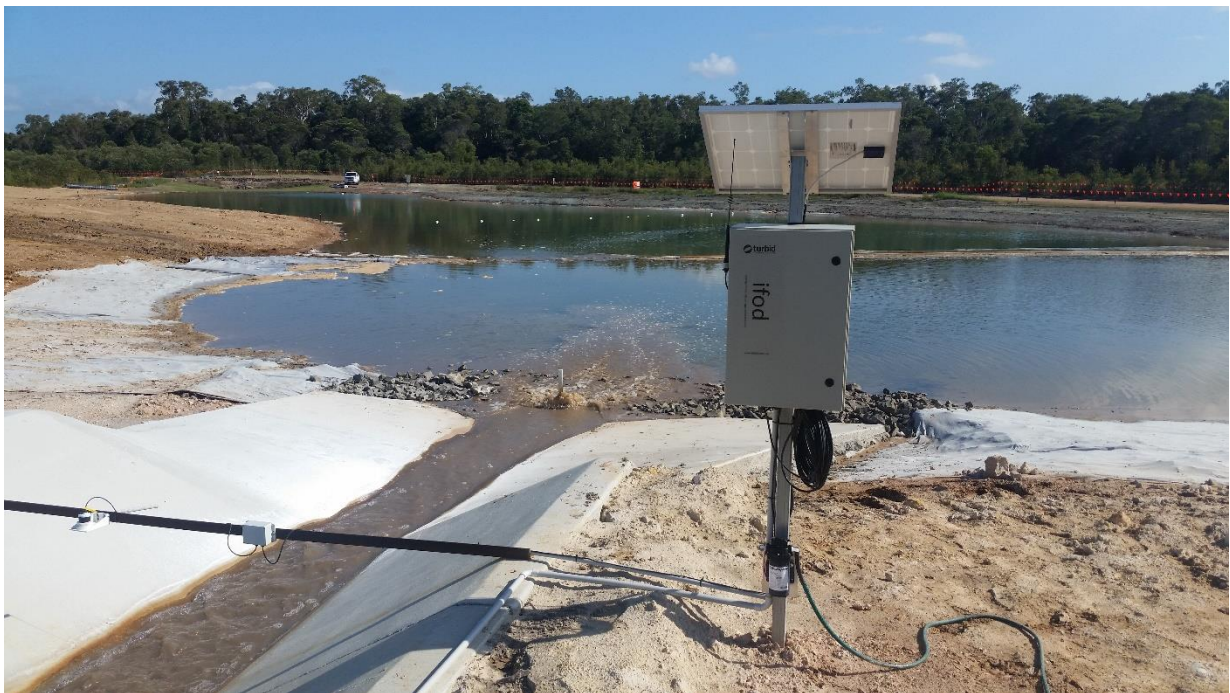
Image 2. Ifod FLOW dosing system

Examples of previously installed HES basins with the proposed equipment are displayed in Images below.

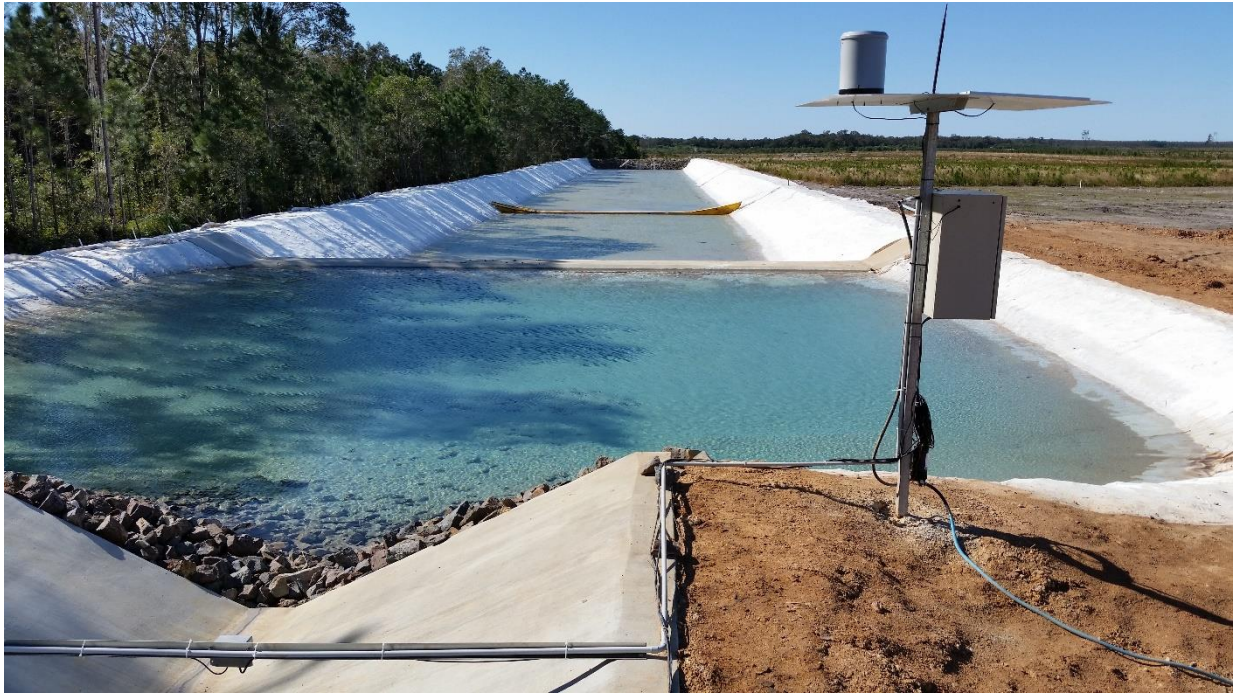
Image 3. Ifod FLOW dosing system

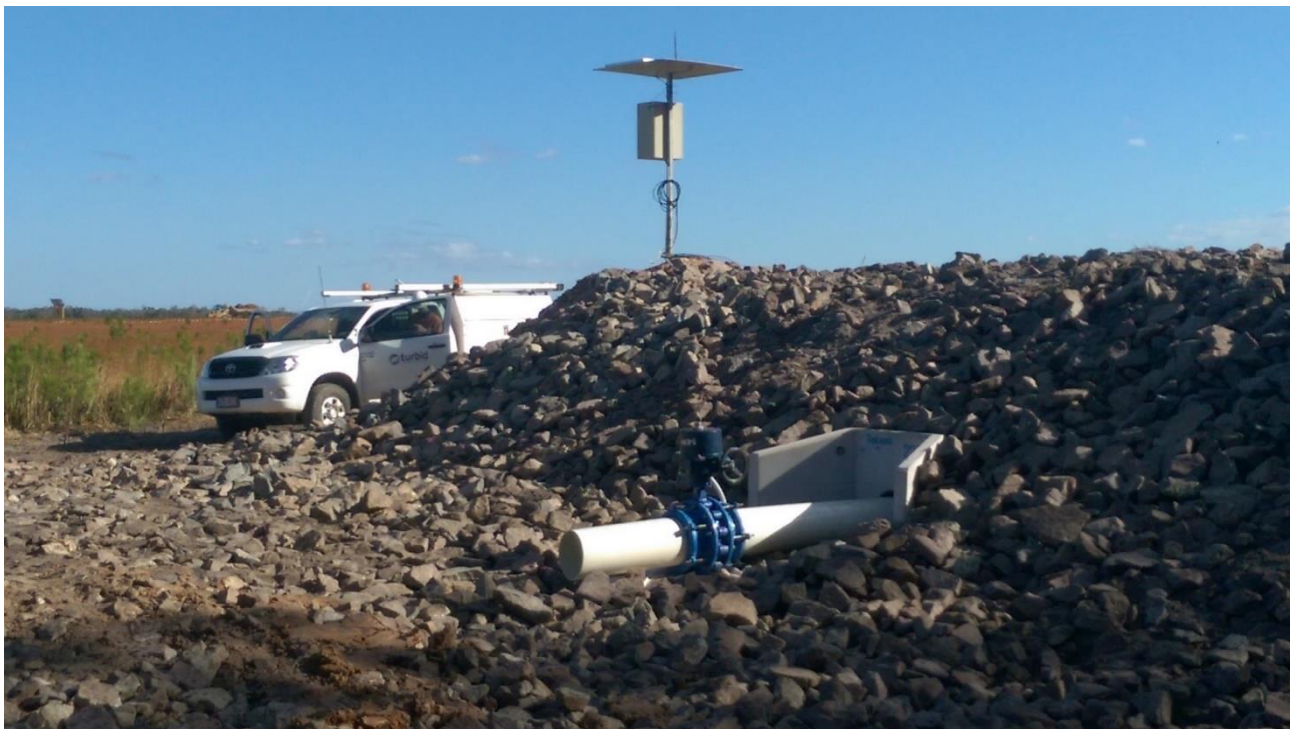
Image 4. Iqad monitoring system with auto controlled shutoff valve on outlet.

- The iqad™ attaches to the discharge point of the basin and allows for the recording of the basin's discharges when occurring. The iqad™ can also control a power actuated butterfly valve installed on the discharge pipe to stop any water discharging that is not within parameters set in the site's license conditions. All information can be logged or exported from the controllers via telemetry to our cloud-based data platform.

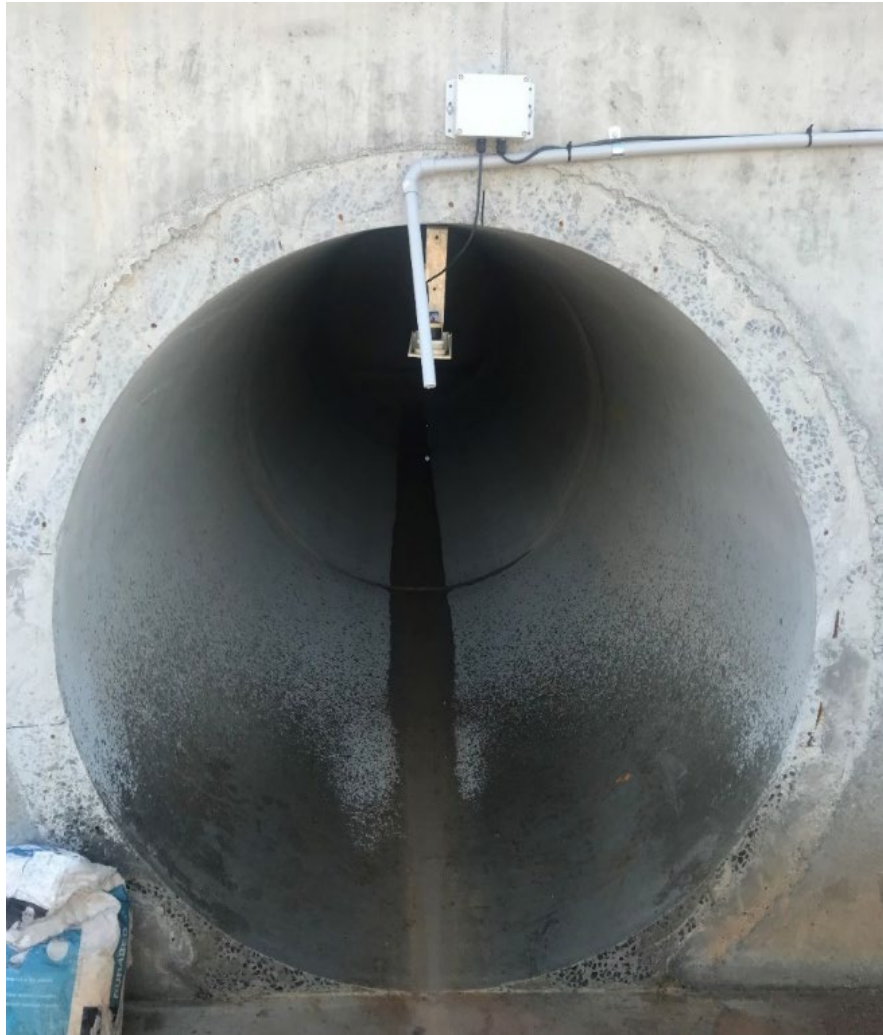
Mounted Ultrasonic Sensor and coagulant discharge line above flow of water

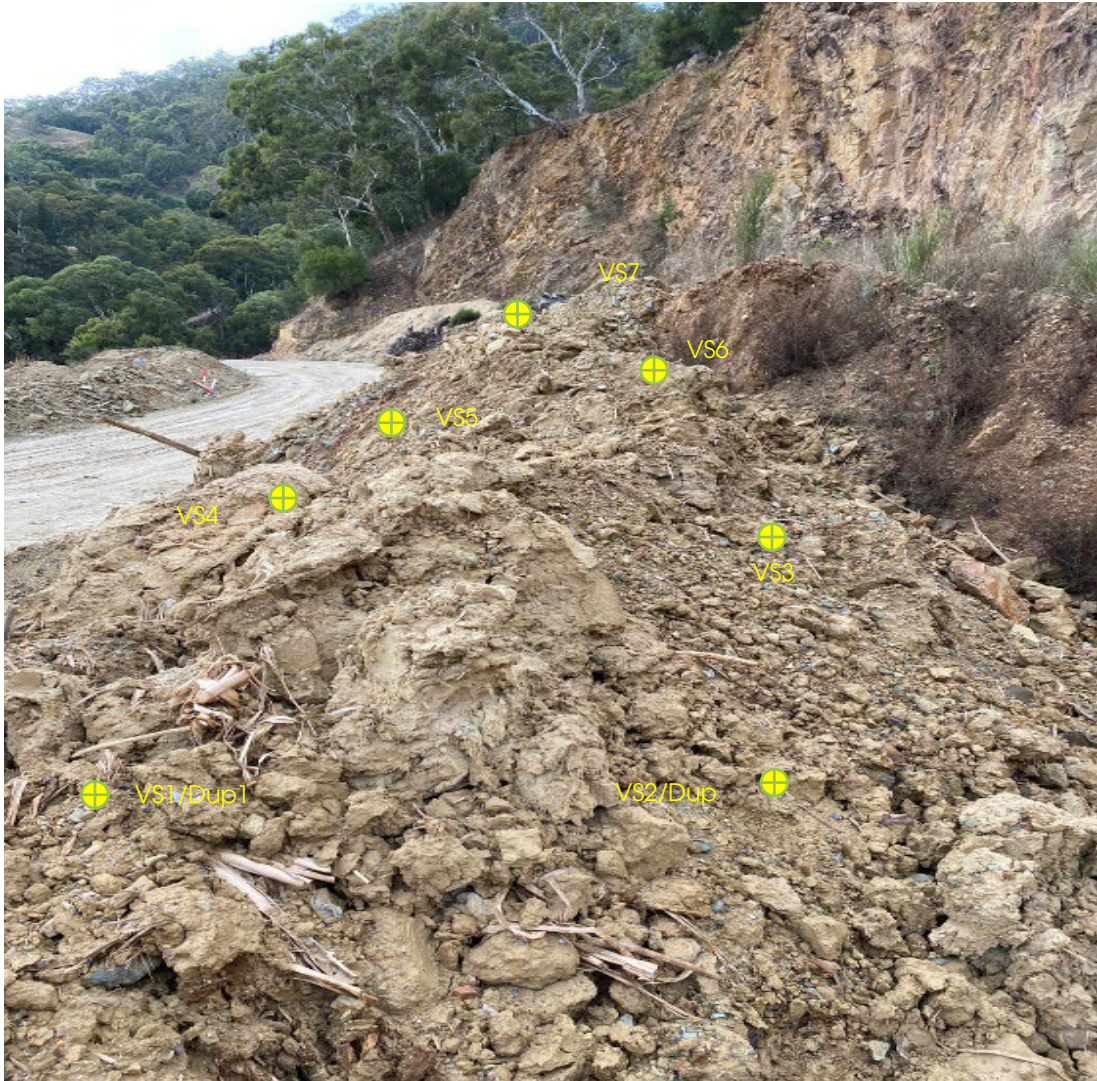
Figure 5.1: Sample retrieval location plan

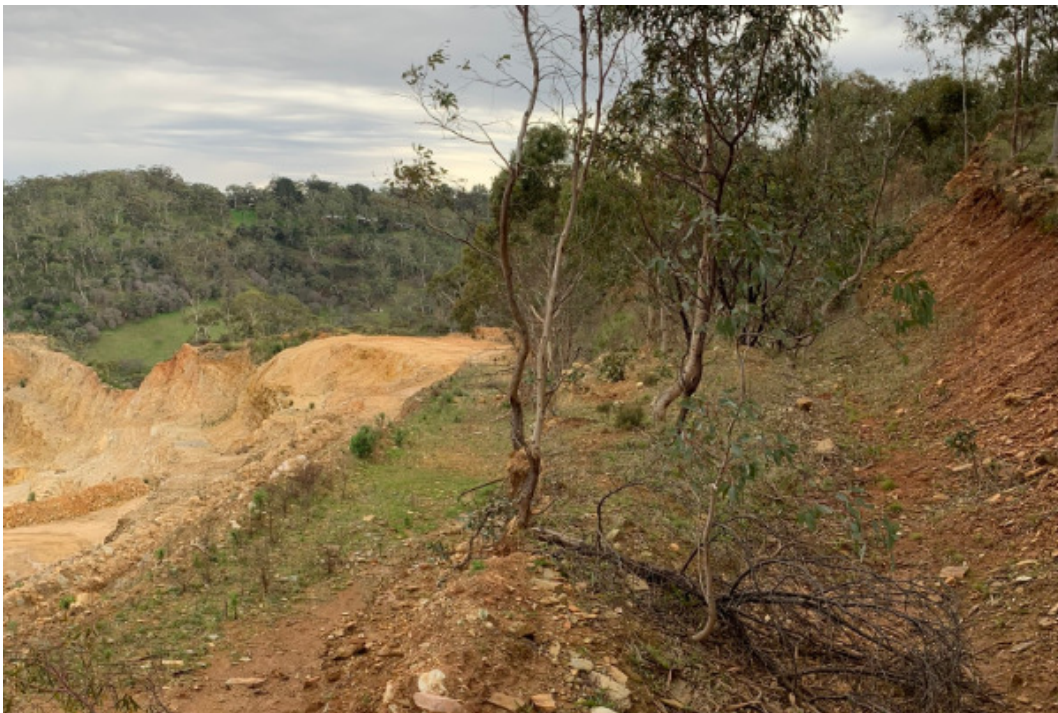
Weeds appear in the overburden soon after the batters have been formed (*see Fig.1*) and where left un-planted are followed over time by trees and shrubs seeded naturally from surrounding vegetation.

Fig 1 Volunteer growth on overburden

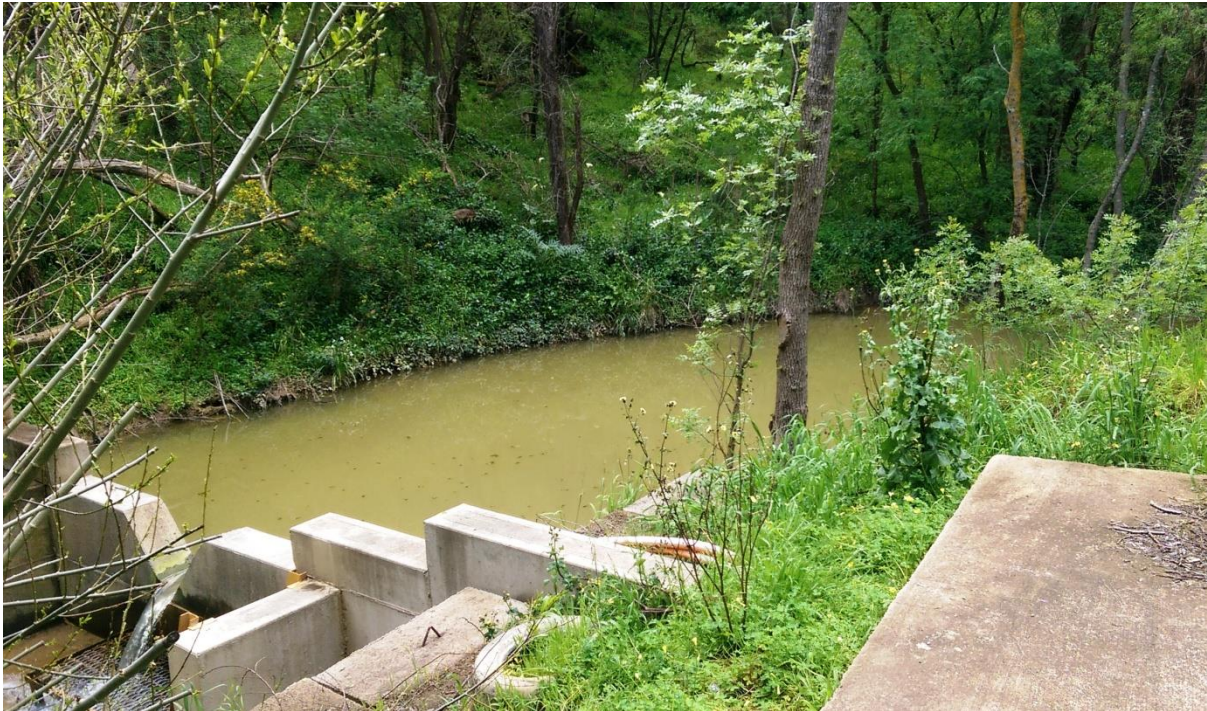
A photograph of the weir is shown in Figure 5-1 below.

Figure 5-1 : Concrete Step Weir

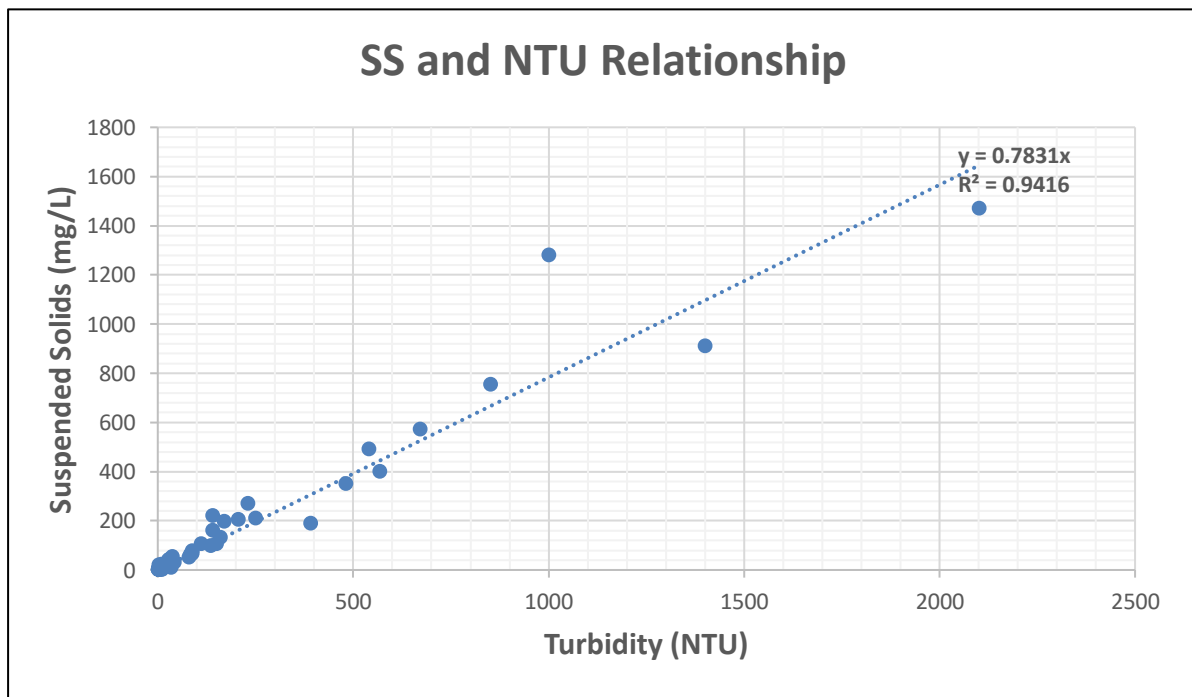
The regression curve is shown in Figure 5-2.

Figure 5-2 : Turbidity - Suspended Solids Regression Analysis

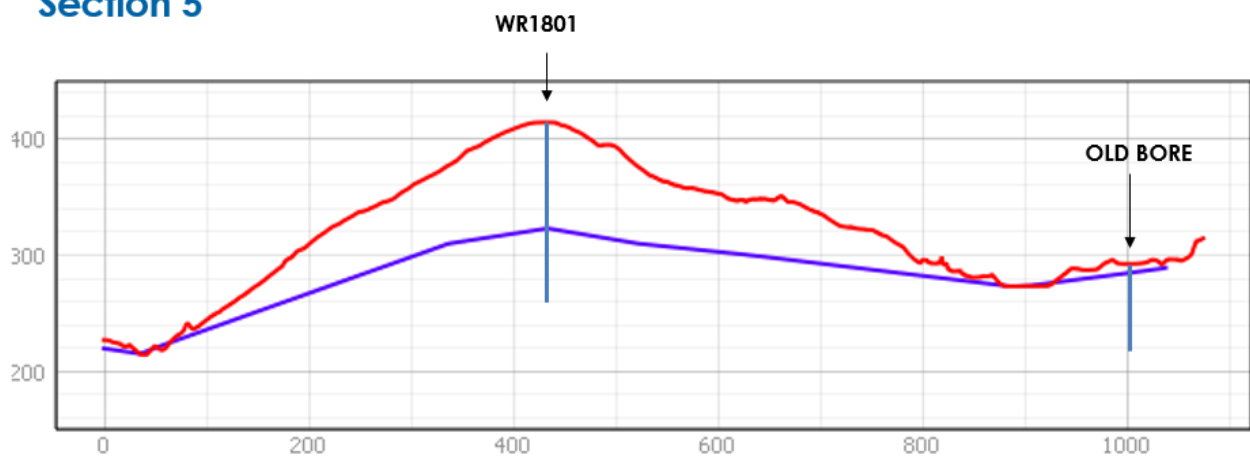
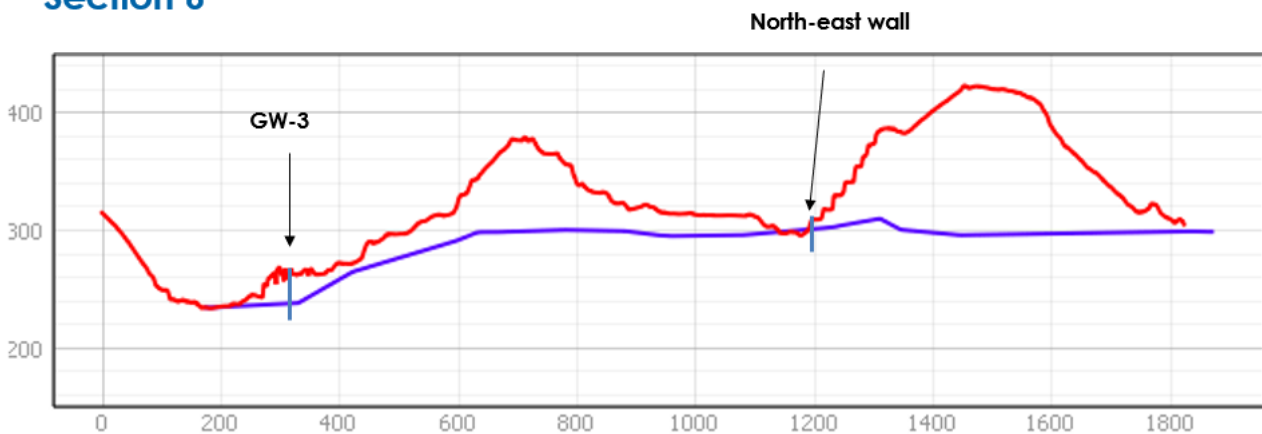
Figure 2.8: Cross Sections 4 to 6 illustrating groundwater surface with respect to topographic position (mAH). Blue is groundwater table, red is topographic surface.

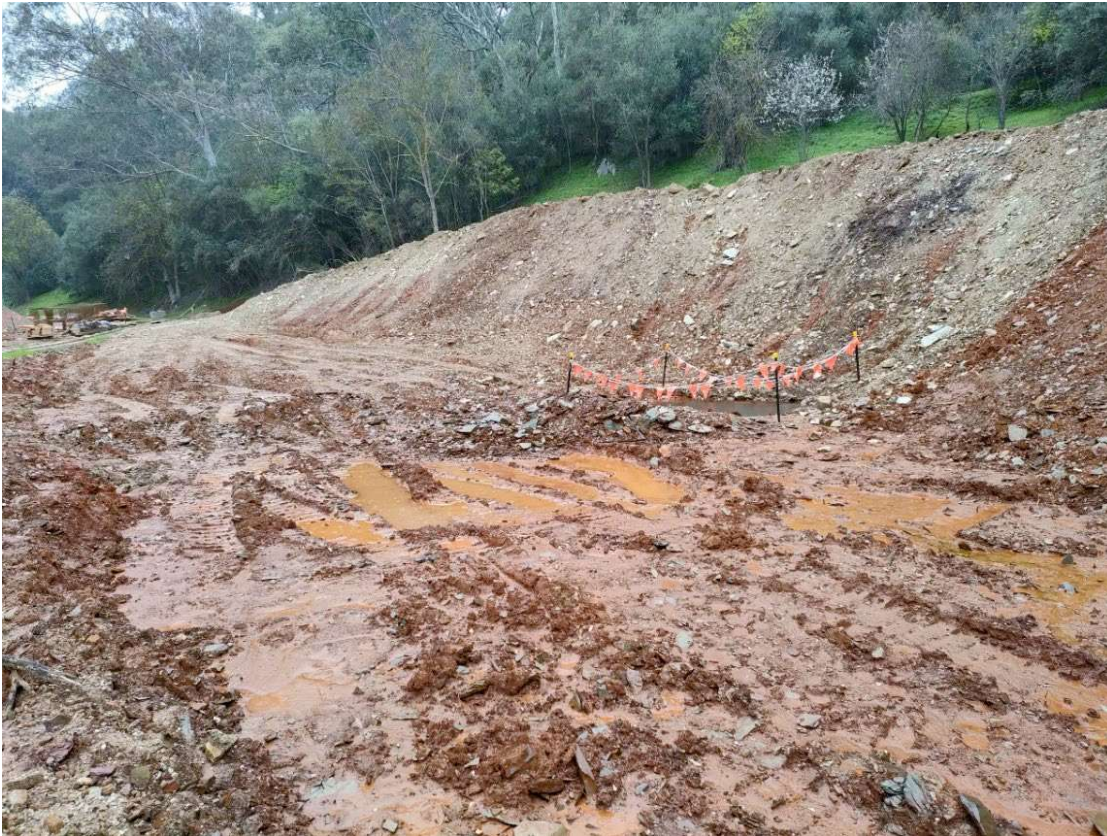
Figure 3. Current progress of the sediment basin (August 29 2022). Note the sump cordoned by flagging tape.

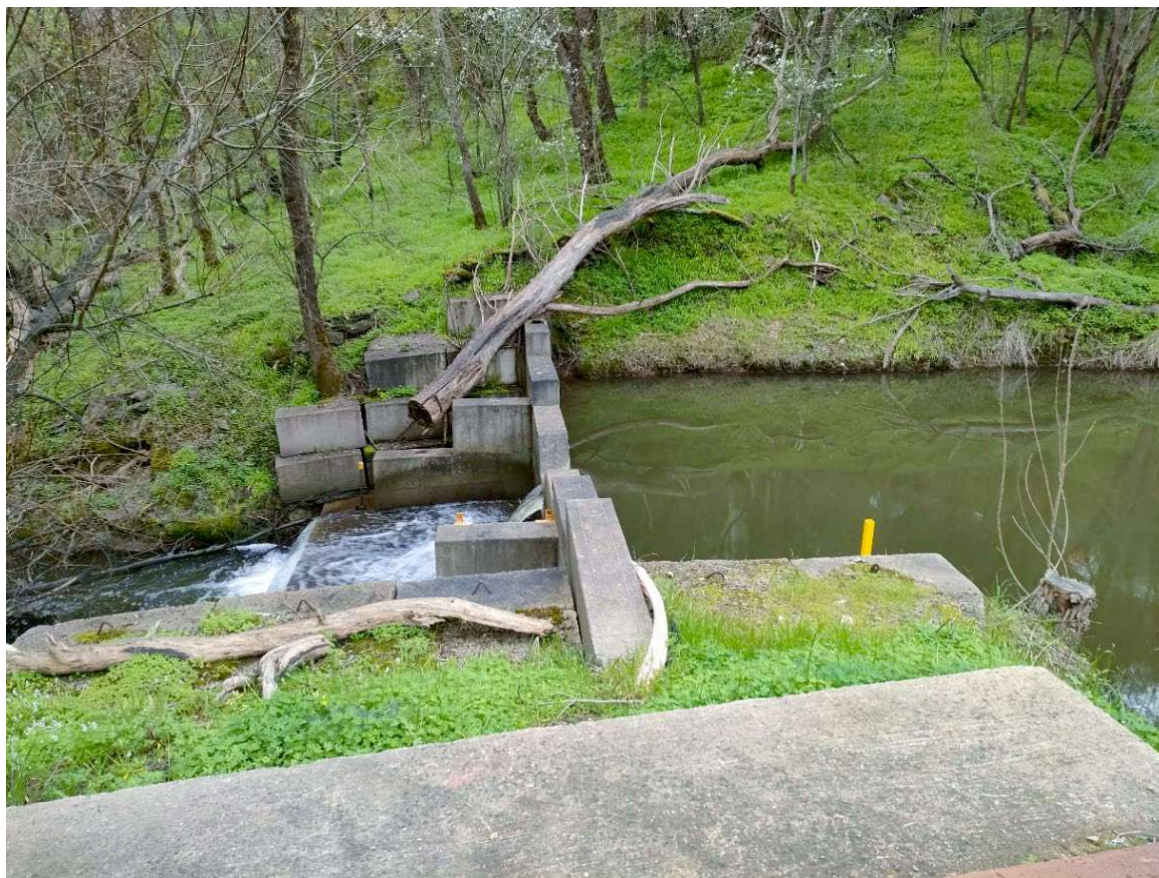
Figure 5. V-notch weir constructed in 3rd Creek, approximately 120 m downstream of the sediment basin.
